Cliff Reconnaissance Vehicle
test campaign in the Dachstein ice cave

Mars cave exploration simulation

27th of April to 1st of May 2012

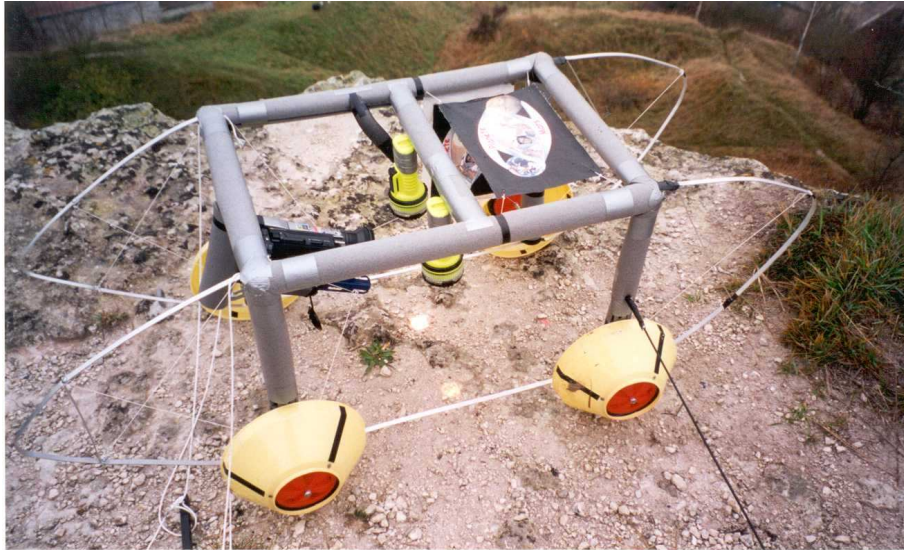
The CRV 1 before a test in Vernon

CRV 1 general configuration

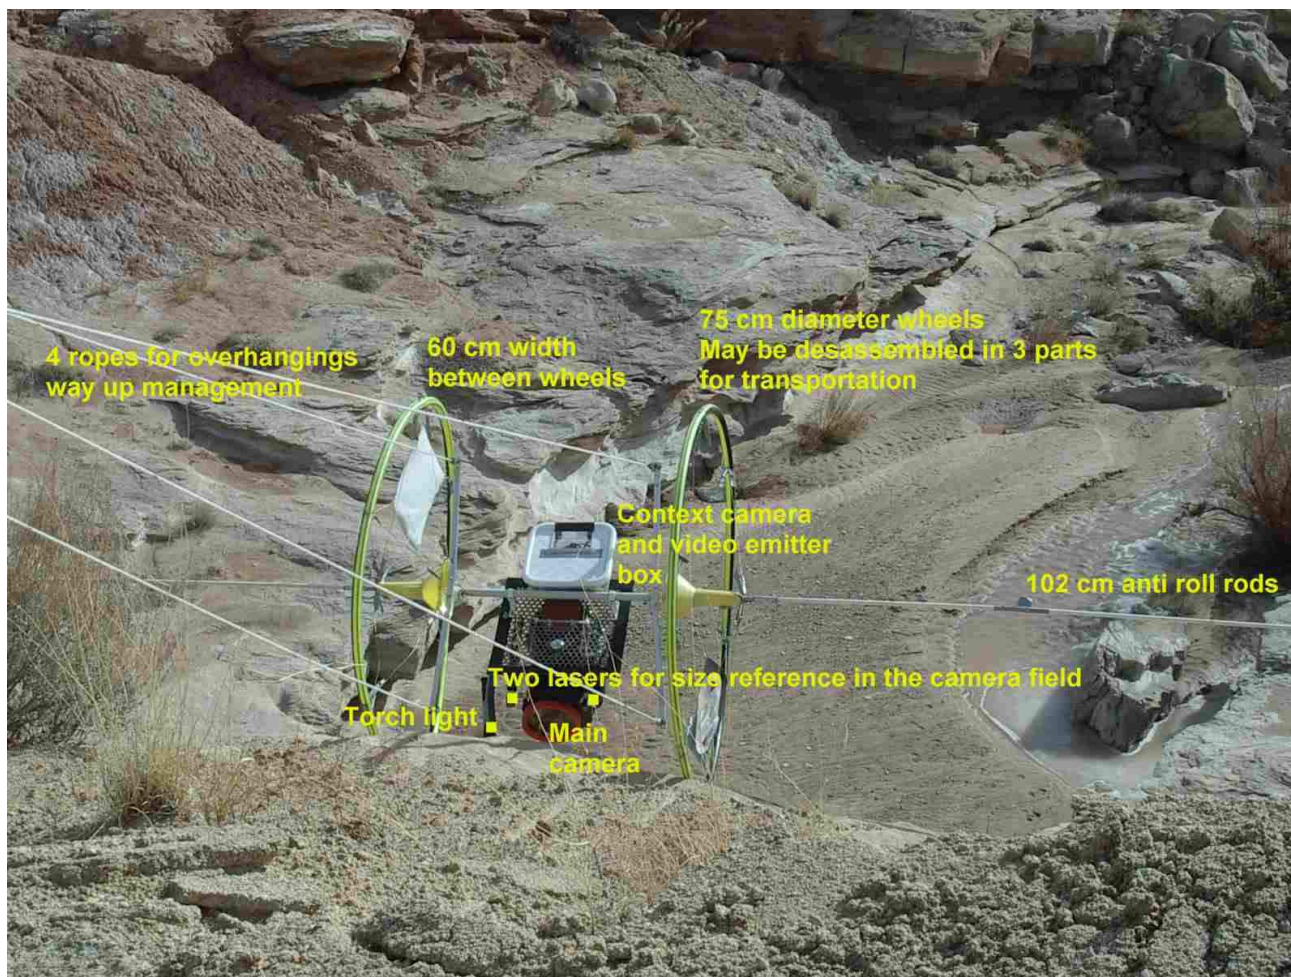
Cliff Reconnaissance Vehicle n°3 main features (CRV test 70 at White Rock Canyon during MDRS 43 in 2006). Small modifications were introduced between this configuration and the CRV 3-3 configuration tested in Dachstein.

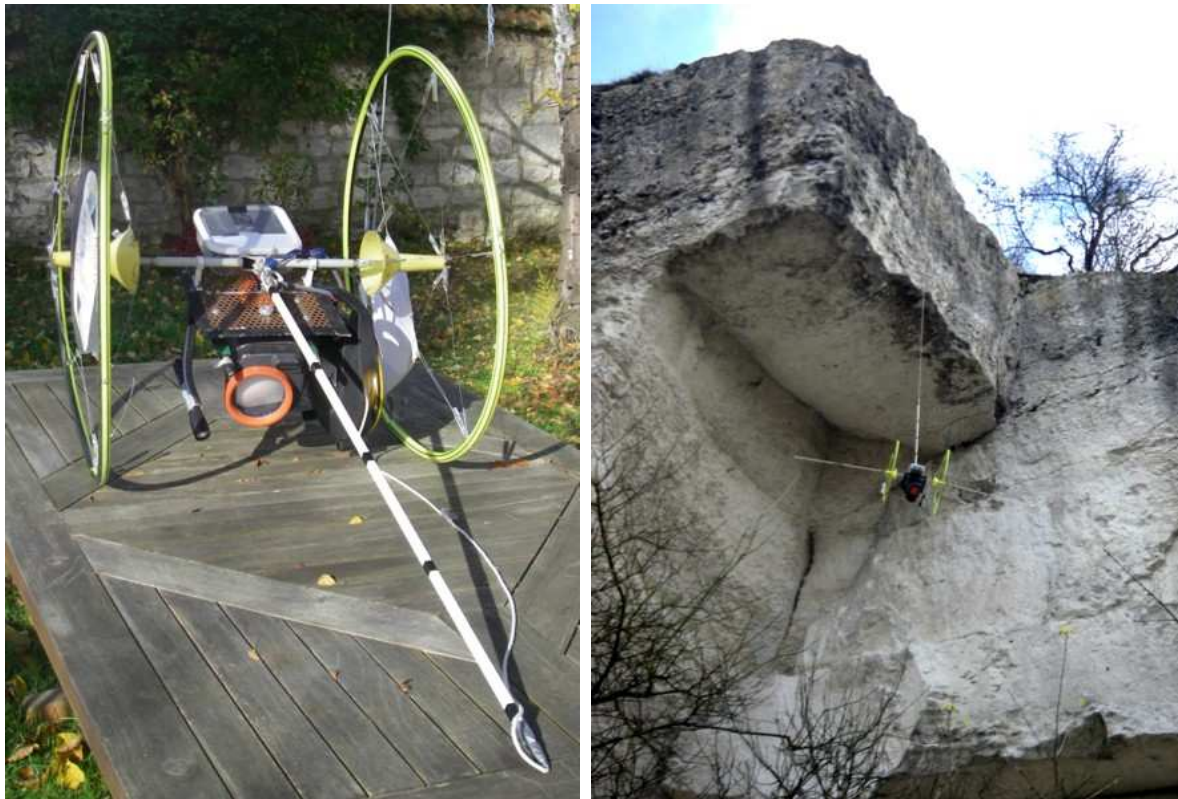
Test CRV 75 in Vernonia, Oregon, November 2008 in order to check the new suspension configuration ability to cross a cliff overhanging part in the up direction. The new suspension configuration were the 2 ropes then 4 ropes suspension is replaced by a semi rigid pole or rod linked to a single rope, is shown on the left. This CRV version is designated CRV 3-2

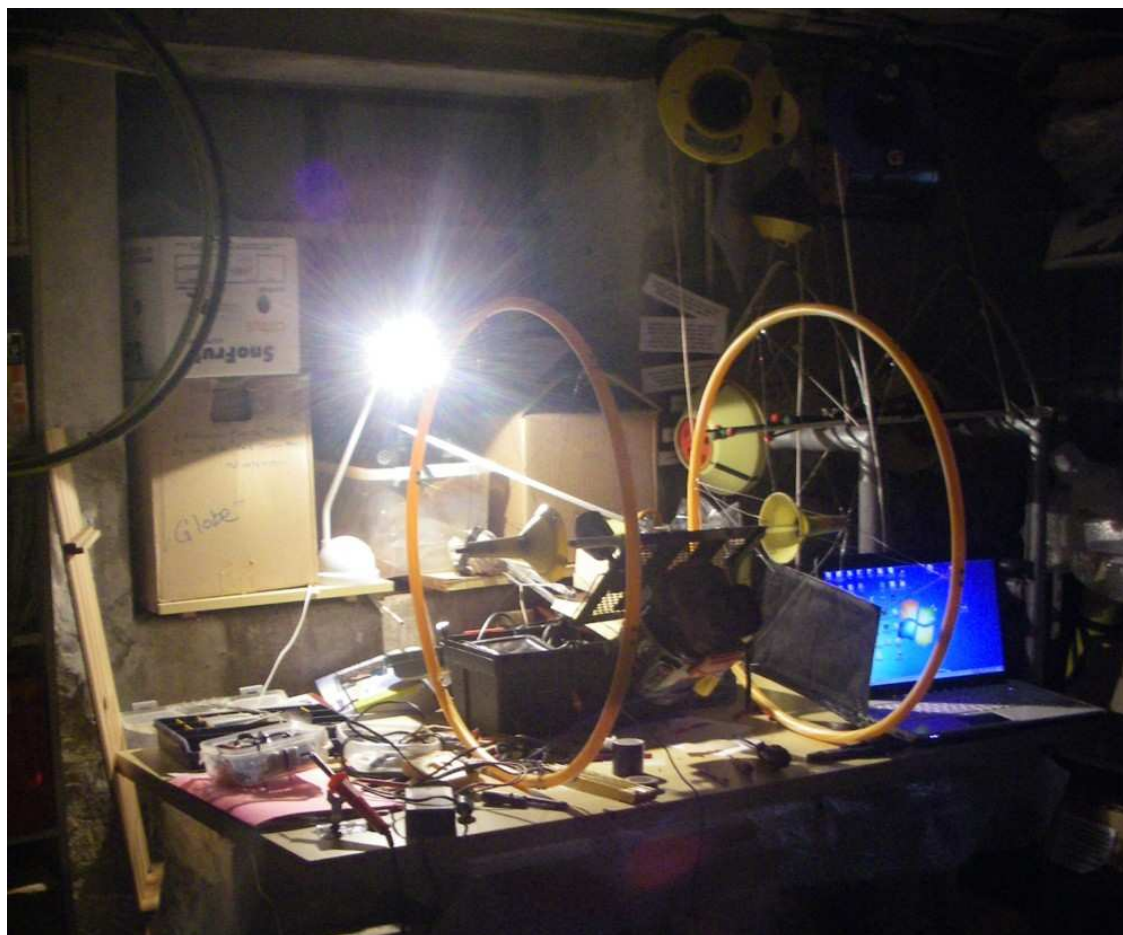
CRV 3-3 preparation in the workshop

The plastic hoop wheels have been changed. The diameter is the same: 75 cm. But the torus diameter is slightly higher: 2.0 cm compared to 1.8. The wheels are thus a little stiffer. Distance between the wheels is 57 cm. All the spokes which were rather corroded from last mission in Utah were replaced. A conical reinforcement band was added on the hub on the internal spokes side around the holes

The camera container porthole which was broken was changed and the circle band around was renewed. The plate used to screw the container on the instruments plate was also repaired. All these damages came from the free fall experienced by the vehicle during the last campaign in Utah. This fall came from a bad fixation of the rope to the vehicle and not from a rope rupture.

The two lasers were replaced by two new more powerful ones. These are green 1mW class 2 lasers, 36.5 g each, with an internal 3V alimentation. The two lasers are adjusted to have parallel beams thus giving by the two spots distance (19 cm) a reference dimension in the camera field of view whatever the distance to the scene. The lasers are installed on deformable supports which allow changes in direction and adjustment of the parallel beams.

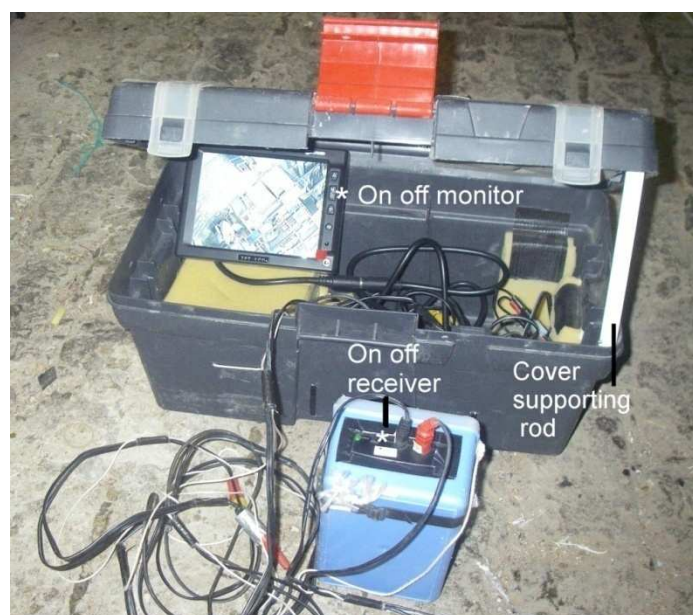
On the left the reception box in its operational configuration with the open cover hold in position by the white bar on the right and the monitor on the left; the spare monitor is located under the yellowish foam protection on the left. In front the blue box holds the receiver. This box may be positioned in the slope for a better video reception. On the right is an example of picture on the monitor.

The emitter has not been changed. It is a wireless Mini TX. The Mini TX emitter has a power consumption of 80mA and can operate between 4.8 and 7.2 V. On the receiving box side the 12 V battery has been replaced by a "NiMH Racing-pack 3700 mAh TAMIYA". The black and white monitor has been replaced by a color TFT Monitor 14.2 cm, 320 x 234 pixels with a 650 mA consumption. A "Velleman TFT LC MONCOLHA 4" color monitor was kept inside the receiving box as a back up. The ALM-2450 2,4 GHZ receiver has a consumption of 180 mA and is using the same 12 V as the monitor. The receiving box total consumption is thus 830 mA.

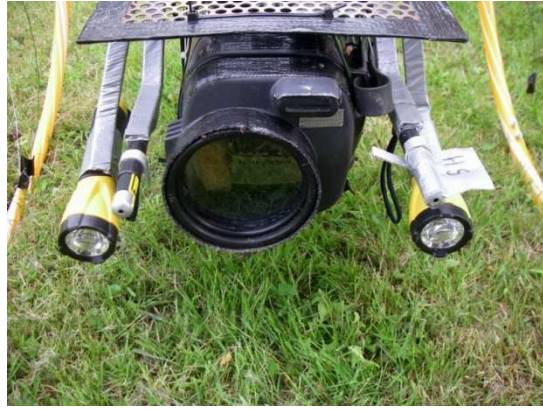
On the left: rear side with the renewed porthole on the camera container, the two flashlights and the two lasers. On the right zoom on the lasers and flashlight.

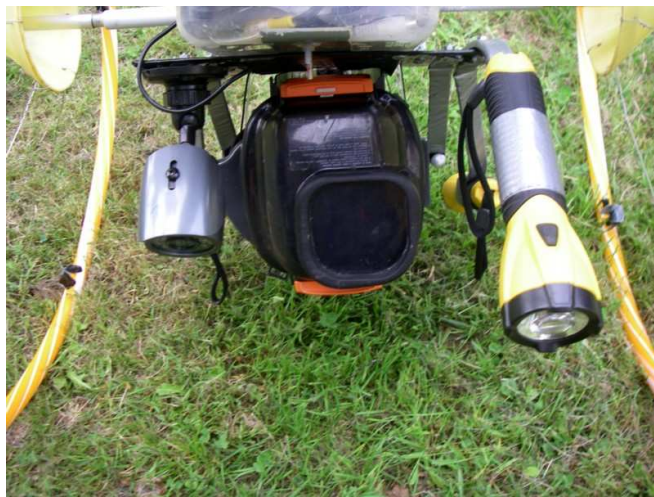
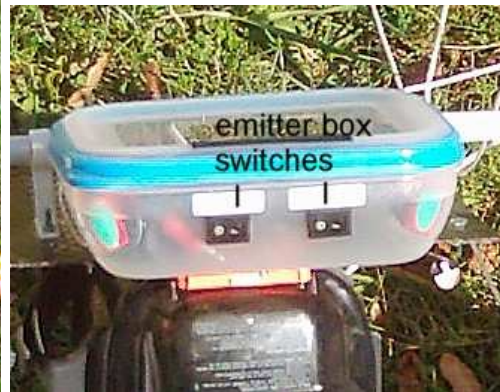
In the left: front side with the hazcam on the left and the flashlight illuminating the hazcam field of view. On the right: the emitter box and its switches.

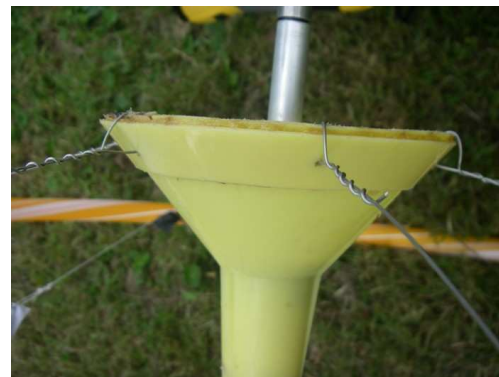
Reinforcement conical band on the hub.

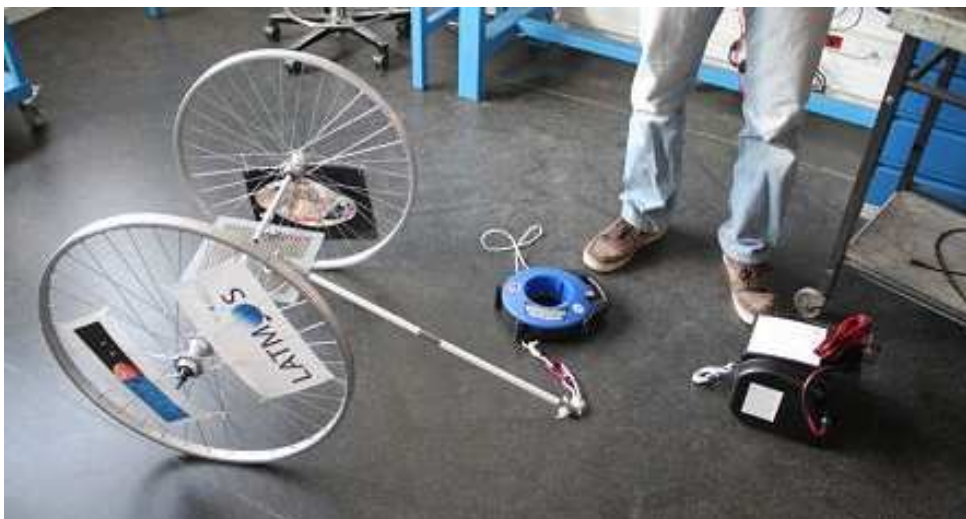
The CRV 5 as delivered to Latmos. The Latmos team changed the instrument plate and added tubes on the wheels. The anti yaw rod and rope were replaced by the cable associated with the electric winch which is on the right of the picture.

The Latmos team purchased an electric winch to operate the vehicle.

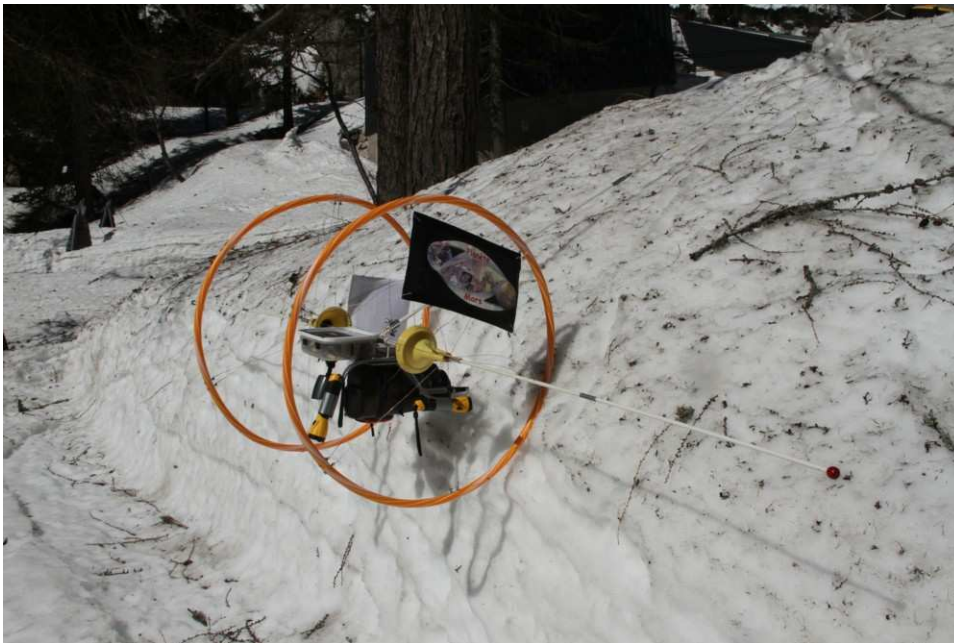
Test CRV 80: first one on snow !

Test 80 was conducted just in front of the cable car station on a 4 m long slope the 28th of april. This test was initially conducted just for fun to see the vehicle operating on snow which was not in the design objectives for the vehicle. The test proved interesting however because in the end one of the spokes bolt was found unscrewed and also all the elements stacked on the main axis were laterally displaced by 2 cm. No large forces are exerted laterally so the two wheels center parts are only glued on the axis. A stronger glue was applied on these elements after the test. Also all the screws on the bolts, holding the spokes, were verified.

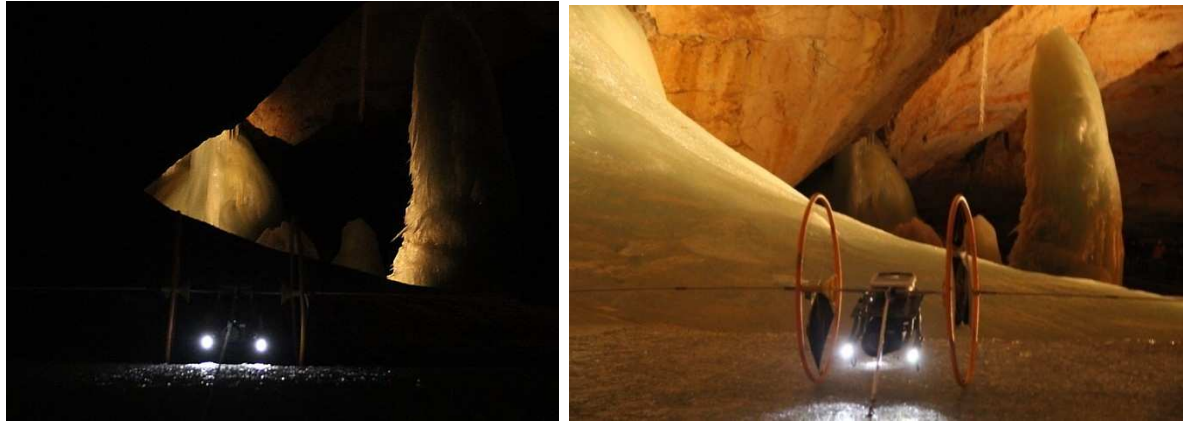
The CRV 3-3 has 3 flashlights for cave operations (two for the main camera and one for the hazcam) compared to one for the CRV 3-2 configuration.

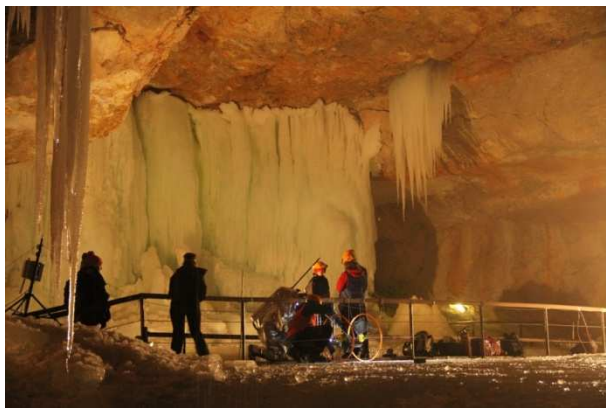
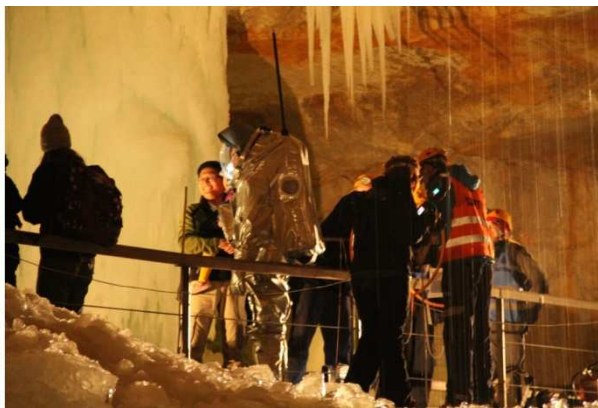
12.36.21(left): The remote recording command is not operating.

12.43.55 (right): Luca opens the container; the camera is found off; the camera is set again on and the recording commanded on the camera directly; then the container is closed again.

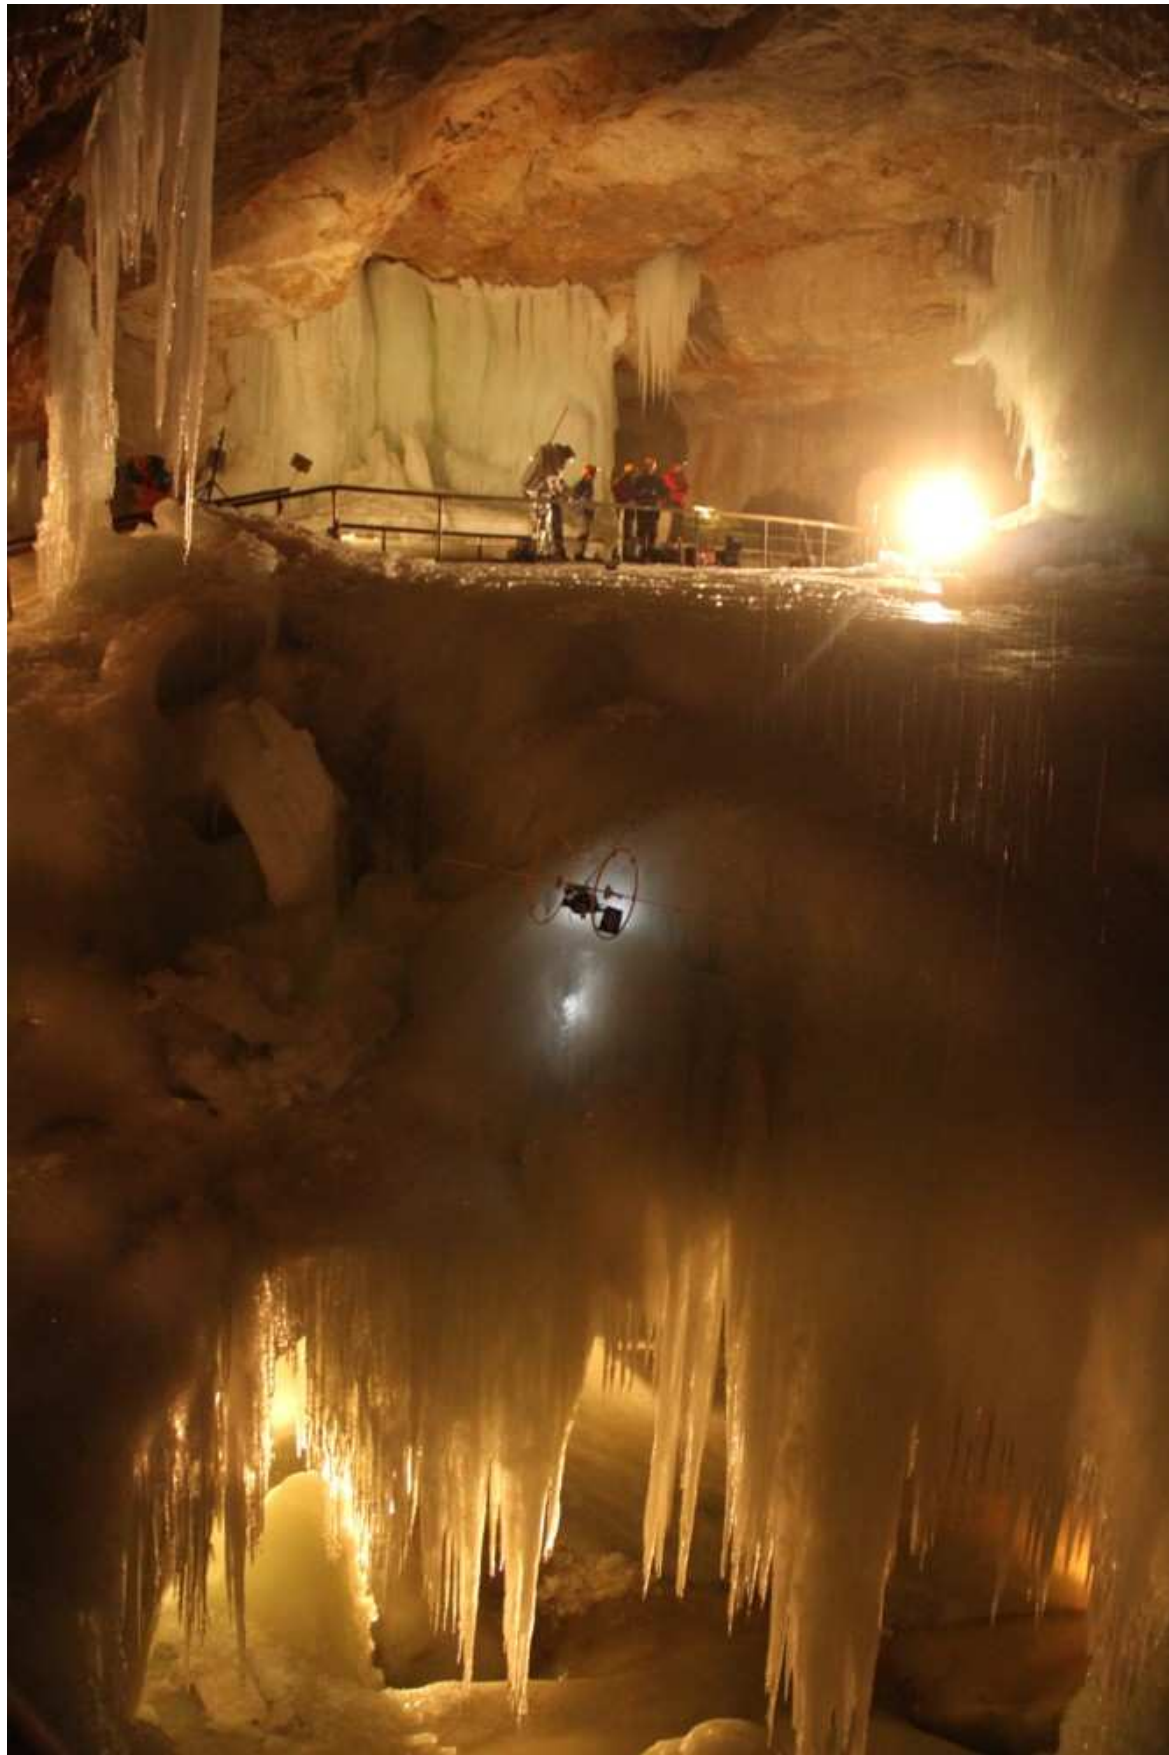
12.50.44: general view showing why the lower part would have been dangerous to go.

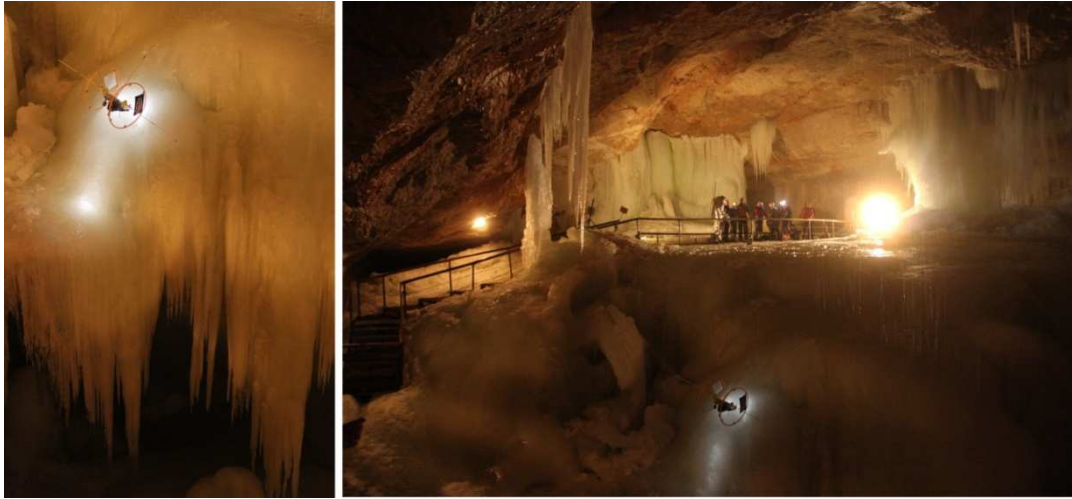
12.51.19 (left): lowest point reached.

12.53.54 (right): general view showing by the vehicle orientation that the rope is not straight between the suit tester and the CRV. The rope does a 60° turn around a small ice peak located somewhere on the flat surface. The descent is stopped there by Luca because, if the ice peak breaks, the CRV could go down suddenly by 2 m entering the dangerous stalactites area.

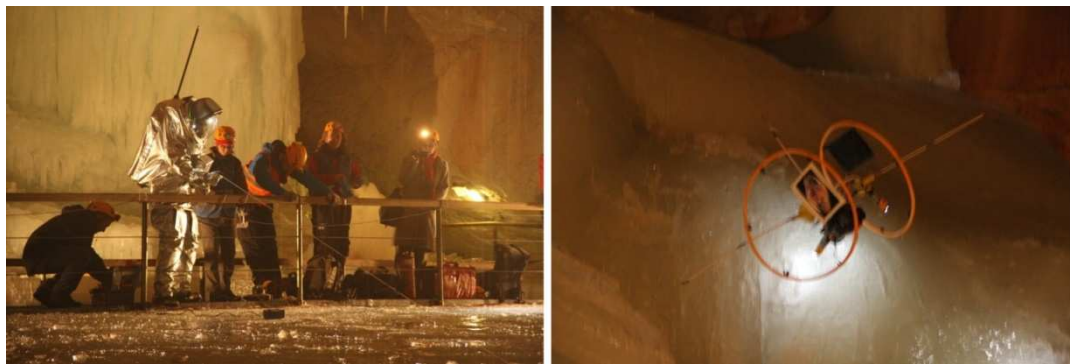
12.56.56 (left): Daniel Föger the suit tester, feels a high tension in the rope

12.55.09: Not only the rope does a turn around an ice peak but the vehicle is also sideways on a ice bump. The anti yaw rod is probably too flexible. Both circumstances increase the rope tension.

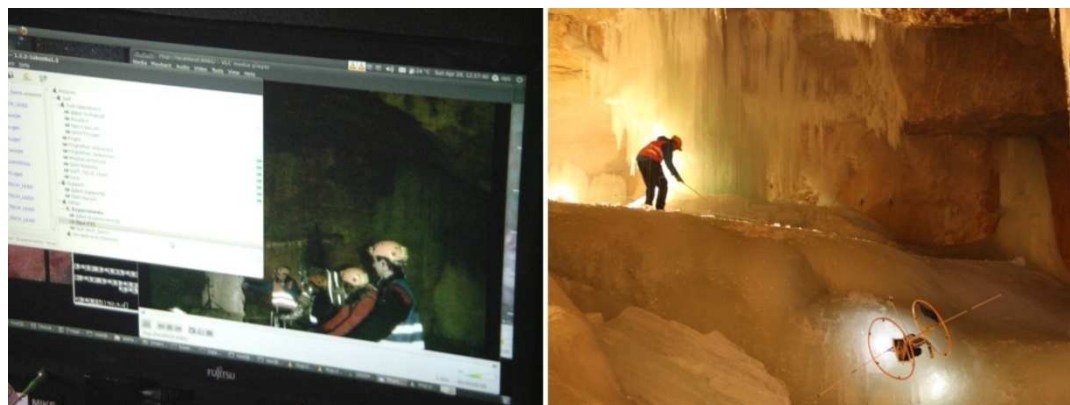
12.57.32 (left): picture received in the operations center when the rope is declared stuck

13.03.54: Ulrich Luger frees the rope from the ice peak.

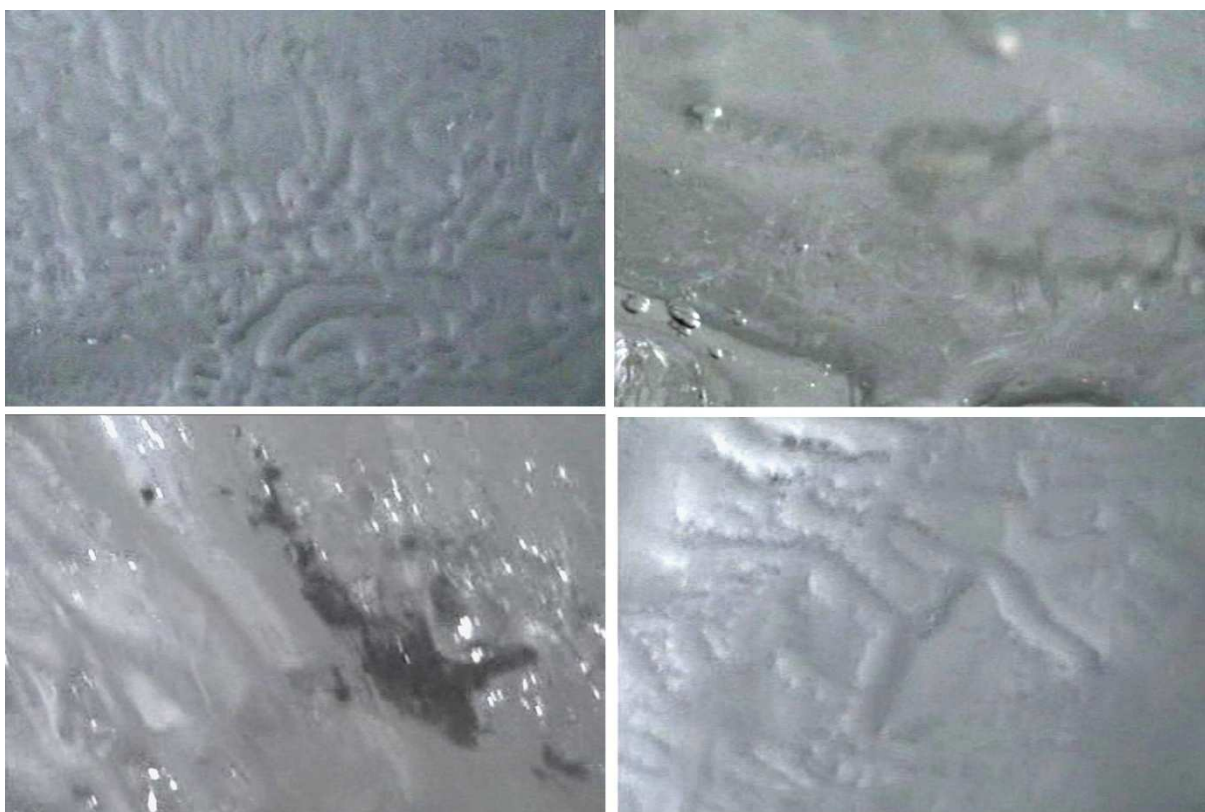
Views taken by the on board main camera at 8mn 15s, 21mn 09s, 22mn 45s and 23mn 04s after the beginning of recording. Most of the time the pictures are fuzzy and blurred. The autofocus had probably not enough details to focus on or/and the camera was no more on wide angle which seems possible because in wide angle the two bright spots of the flashlight should be visible.

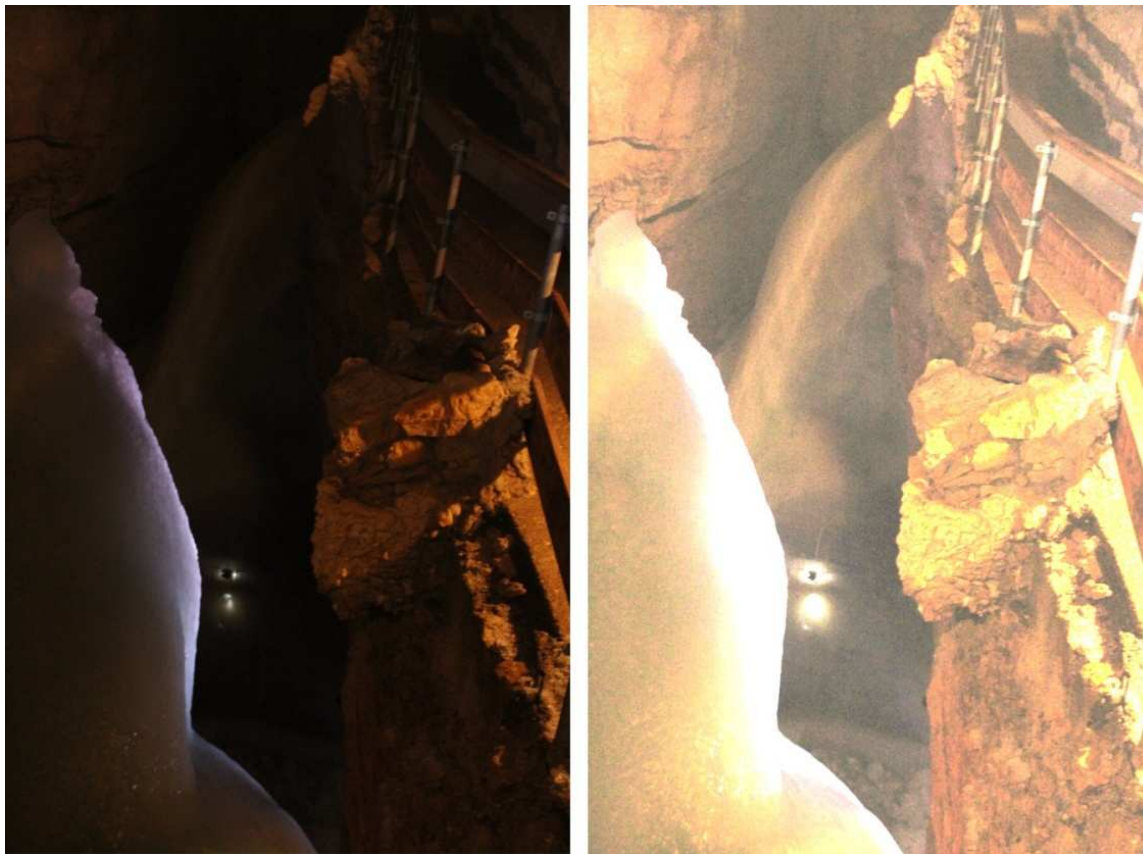
15.28.52: first stop at 13 m with brightened photo on the right showing that the vehicle has derived on the right (left as seen from above) on the ice slope on which it went down.

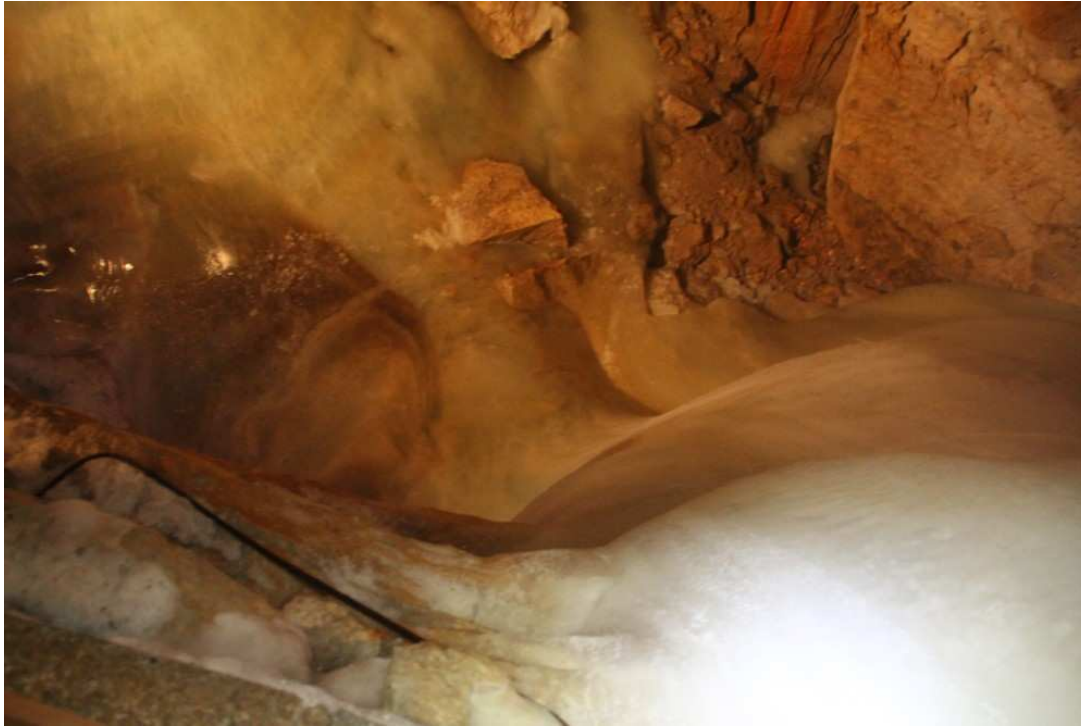
The ice slope as seen from above seemed trap free.

But, as seen from another point on the path way, the trap is clearly visible. These photos were taken the day following CRV 83 test, to better understand the blocking causes.

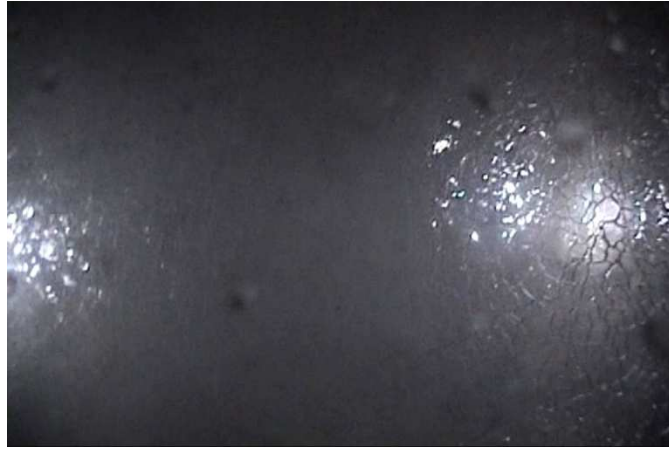
In the first meters of descent, ice is shown with a mosaic like pattern roughly 1 cm wide. The two flashlight spots are separated by 24 cm.

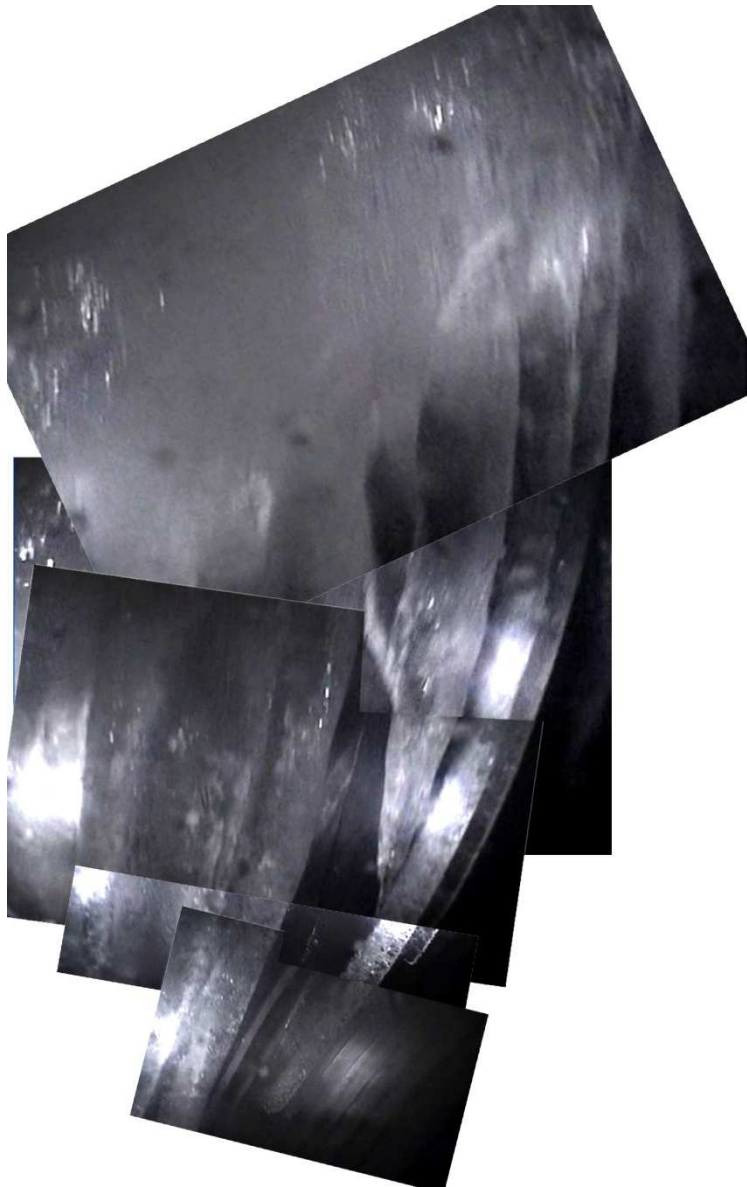
At mid descent the vehicle crosses the field of stalactites which will be an obstacle on the way up and which was not visible from above.

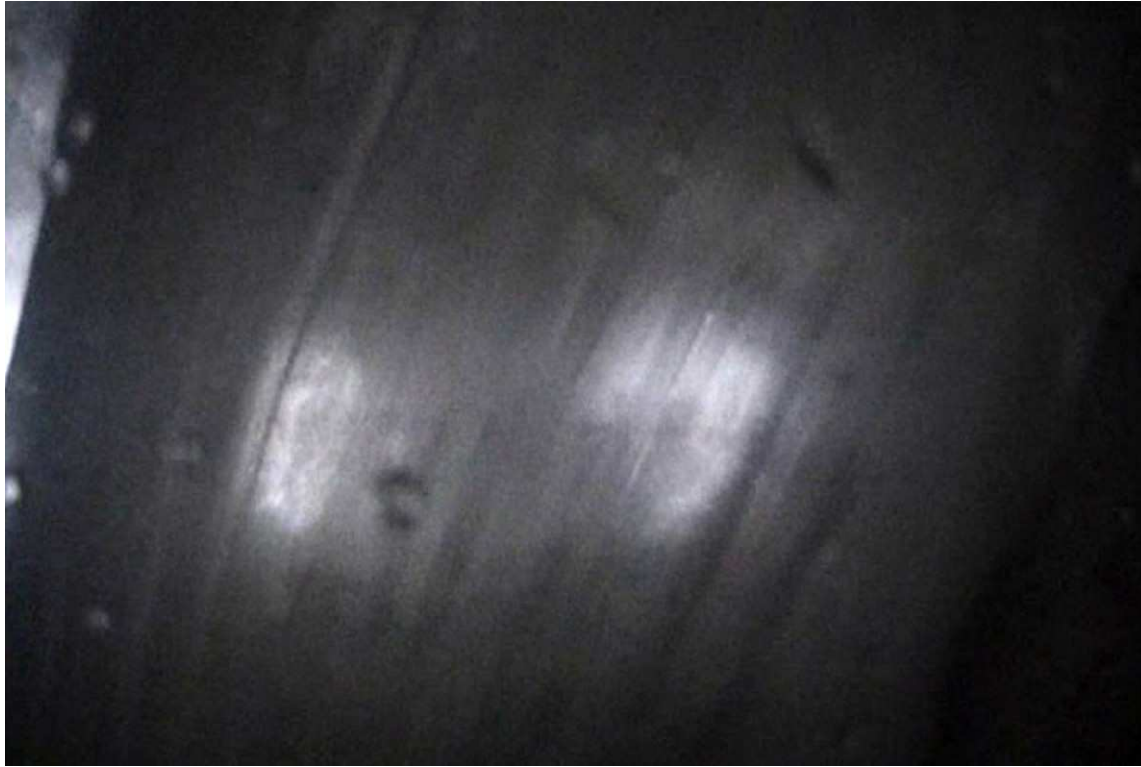
The ice cavity below the stalactites. The vehicle is farther from the icy wall as may be seen by the bright spots seemingly closer and in fact still separated by 24 cm.

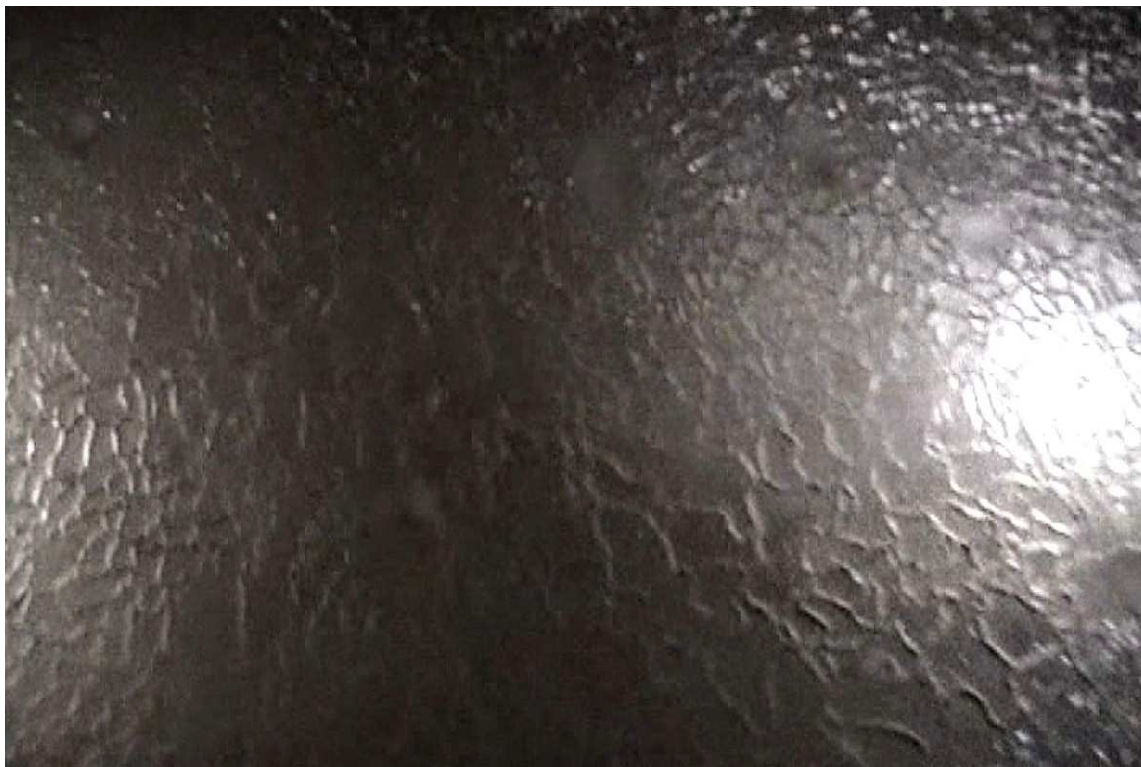
Down the slope the vehicle is again rolling on ice and shows, as above, a mosaic like pattern with structures roughly one cm wide.

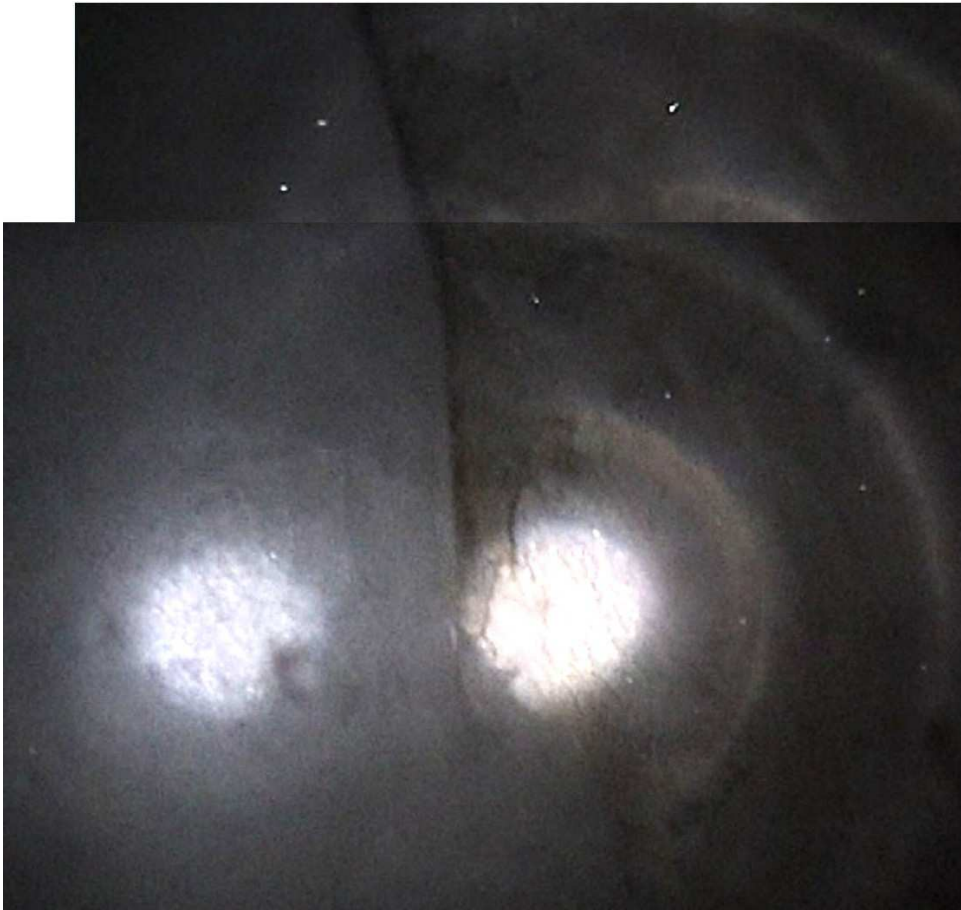
The ascent has started. The vehicle is suspended to the rope and rises exactly at the limit between ice on the left and rocks on the right.

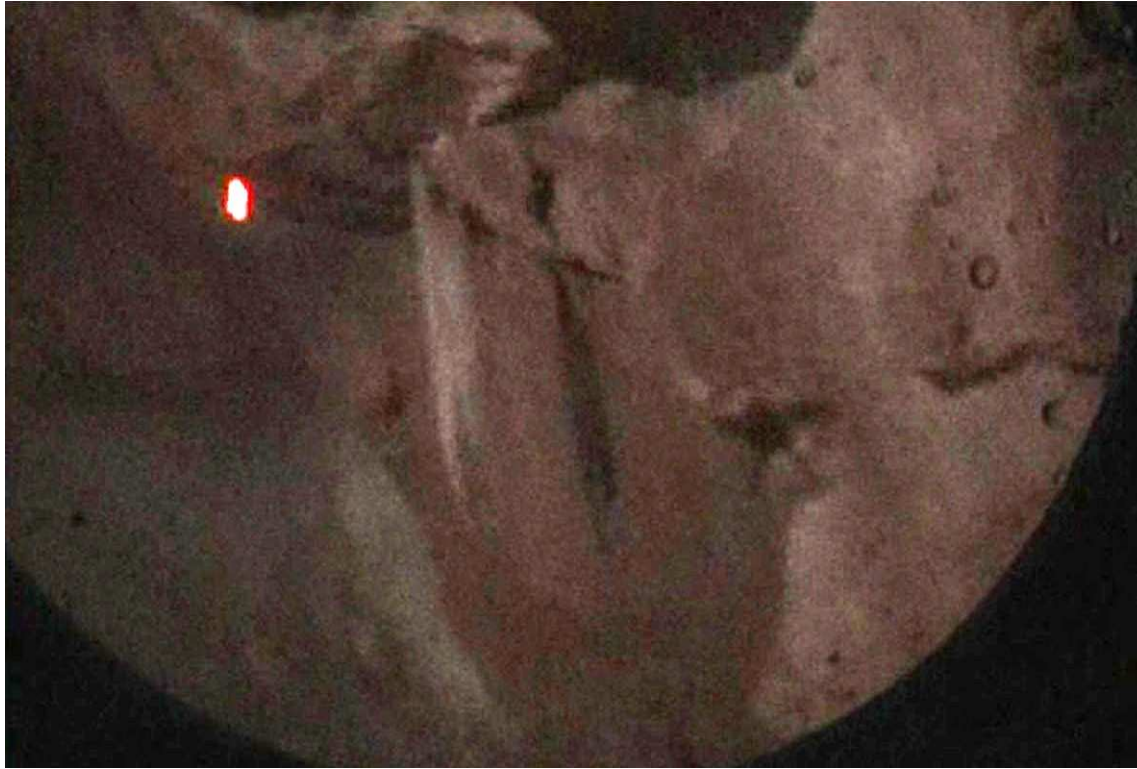
After successfully clearing the obstacle, the vehicle is now “upside down” (but still on its wheels as the design allows) looking to the other side of Tristan dome.

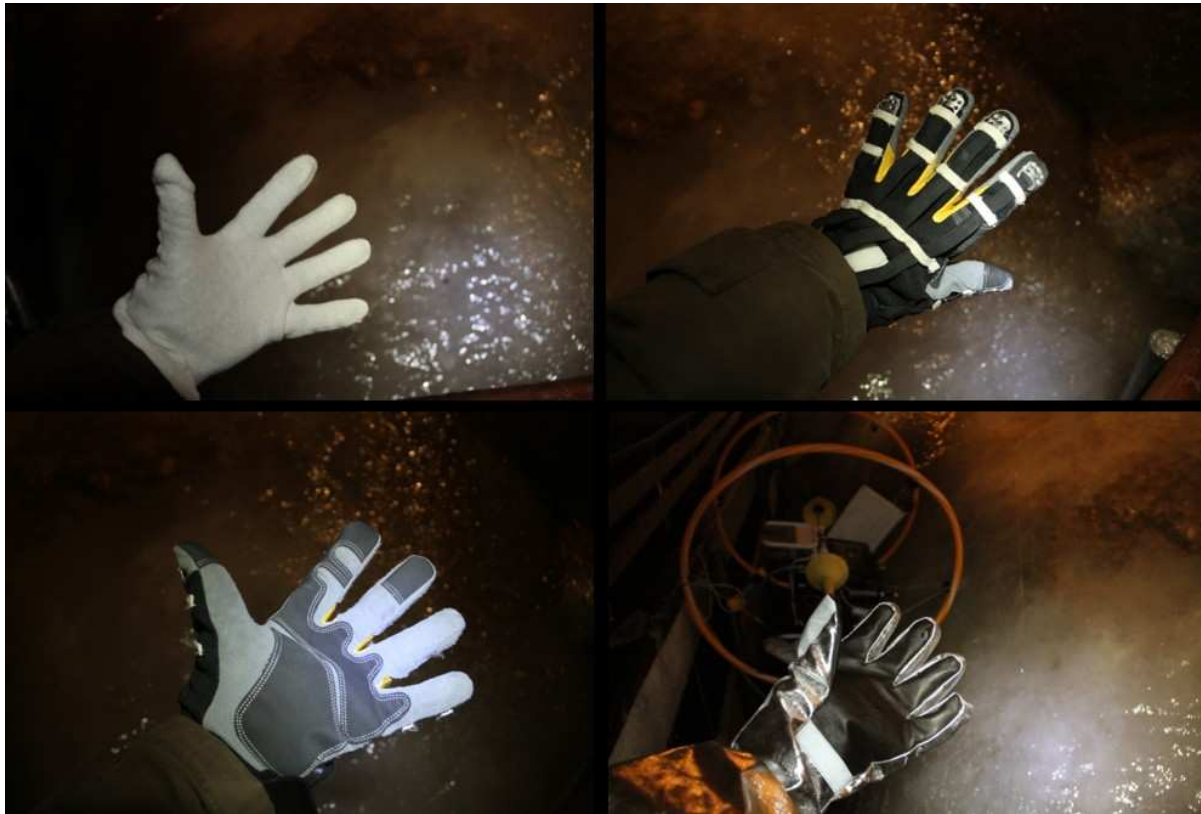
The Aouda three layers of gloves: from left to right and up to down, the comfort glove, the glove restituting the pressure forces from both sides and the outside glove from the palm side.

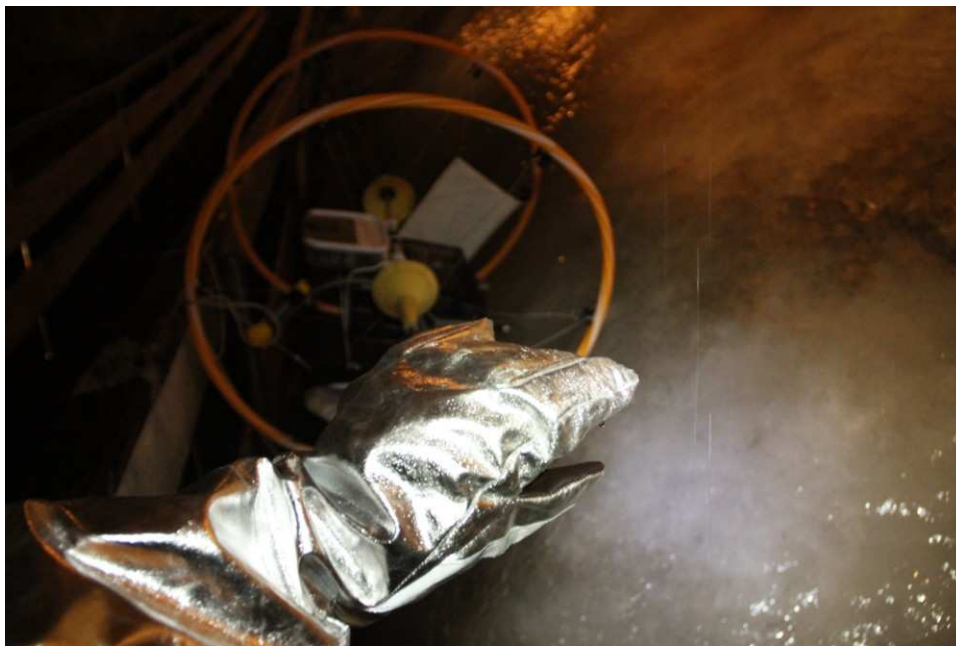
The outer glove from the other side.

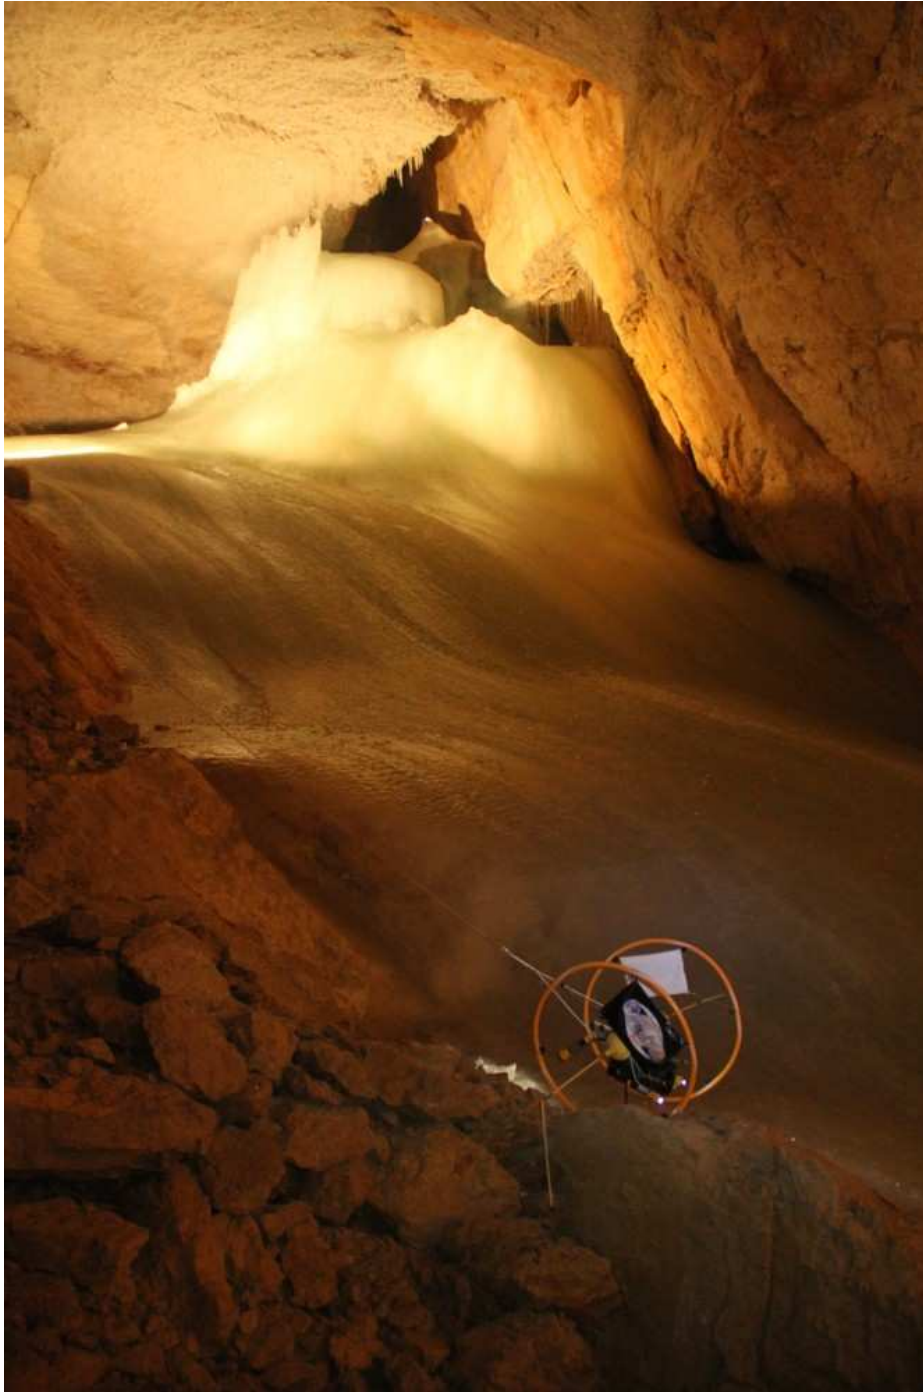
Right anti roll rod bent at the end of test 85.

In the process the right anti roll rod ends being bent. The vehicle is retrieved from a lower point on the path way climbing directly through 4 m of chaotic rocks.
