Cliff Reconnaissance Vehicle
test campaign in the Dachstein ice cave

Mars cave exploration simulation

27th of April to 1st of May 2012

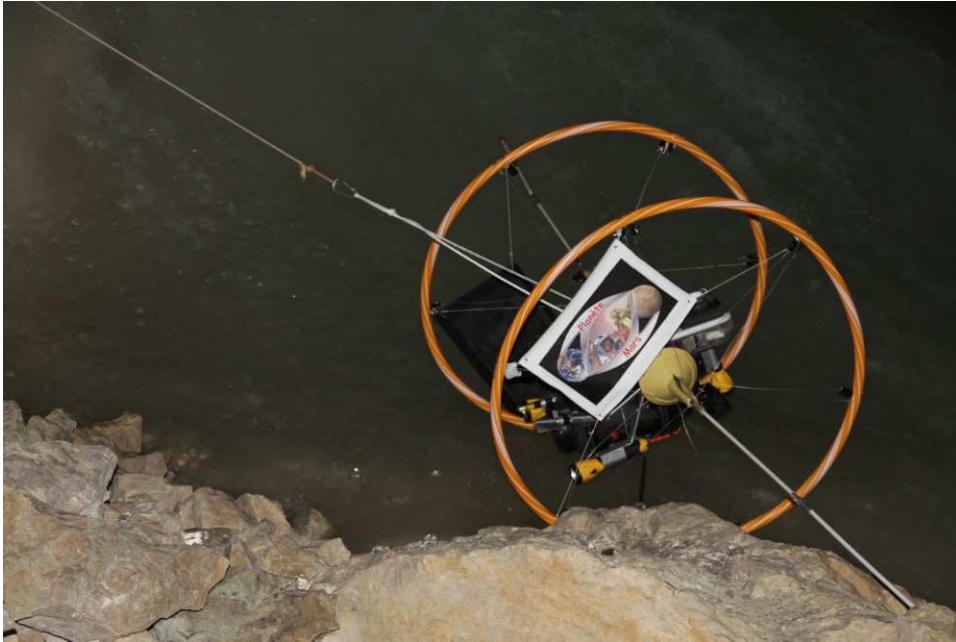
The repair configuration with transition from one to two ropes after the rod attachment failure the day before is visible there.

Test CRV 86 is conducted shortly after 85 from the pathway. In a 4 m ride, the vehicle reaches the ice field and then is brought back. The anti roll rod bent during the previous test has been repaired. The camera is on board but not set on recording. The objective was to demonstrate the vehicle ability to roll on very irregular terrain with rocks reaching around one third of the wheels diameter. And the ride was indeed bumpy.

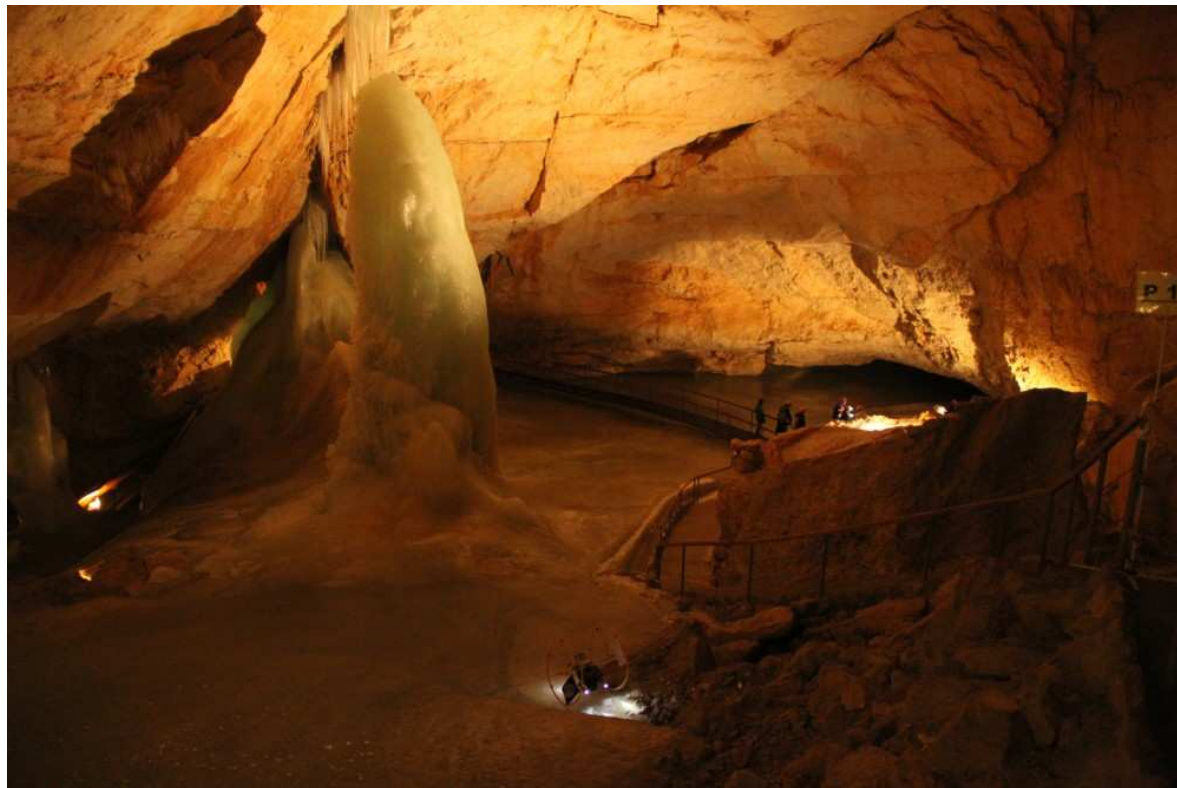
Test CRV 86 has been conducted on the very irregular rocks field on the right between the pathway and the ice field.

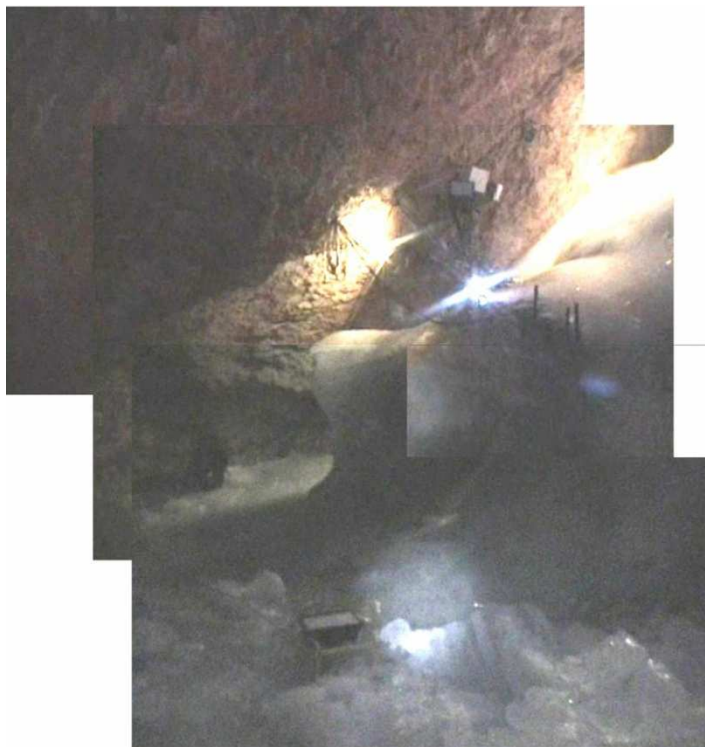
R 2.04 to 2.19: mosaic of pictures taken on board showing the electric installation in the bottom of Tristan dome and the rocky wall under the pathway. These pictures are taken before landing.

The following photos are the ones taken on board (extracted from the video). Time is given starting from the beginning of the recording. The beginning of descent is at 1.15. The photos taken from above as well as some photos of the pictures received on the monitor are shown also, trying to present all the pictures in a rough chronological order. The only time link between outside pictures (general pictures or pictures of the monitor receiving the Hazcam views) and on board pictures is the landing time which is 10.15.00 corresponding to 2.50 in on board recording time. To avoid confusion the recording times are given with a R before.

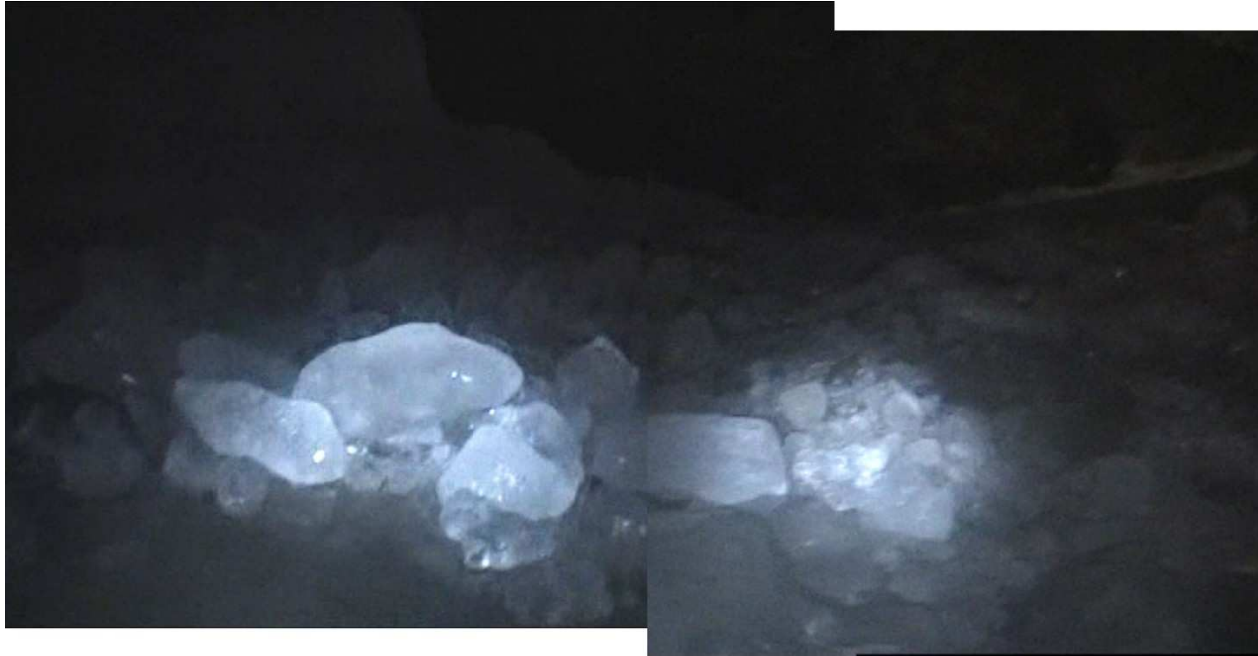
R 2.22 to 2.24: ice blocks on the floor around 30 cm wide roughly 25s before final landing.

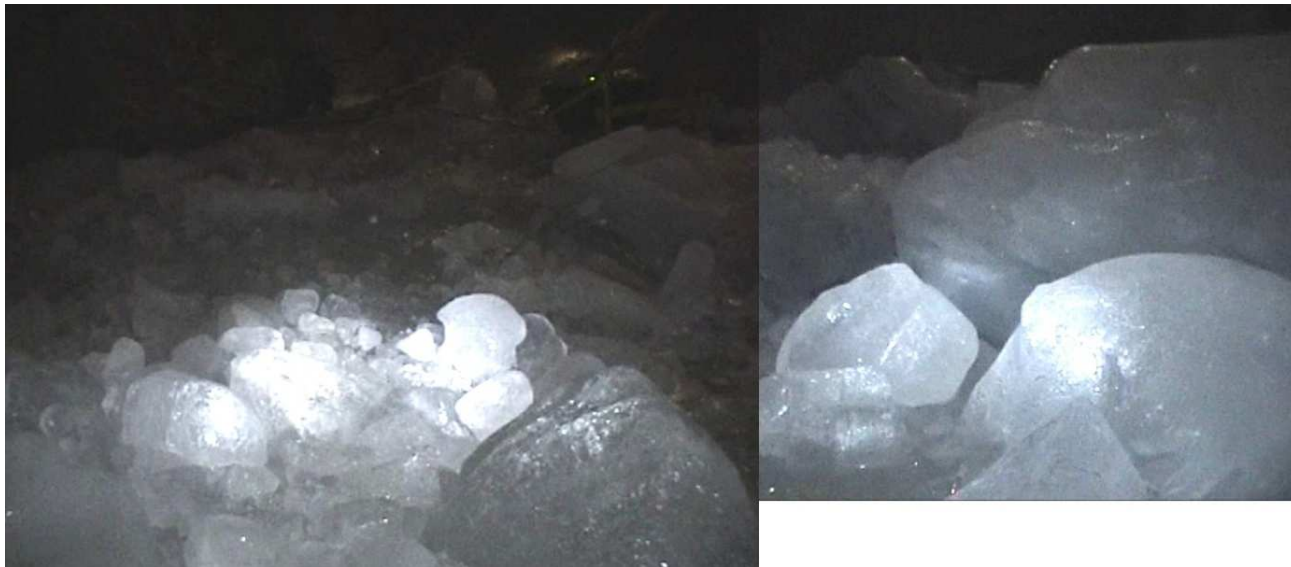
R 2.28 to 2.55: ice blocks on the floor. The final landing is at R 2.50.

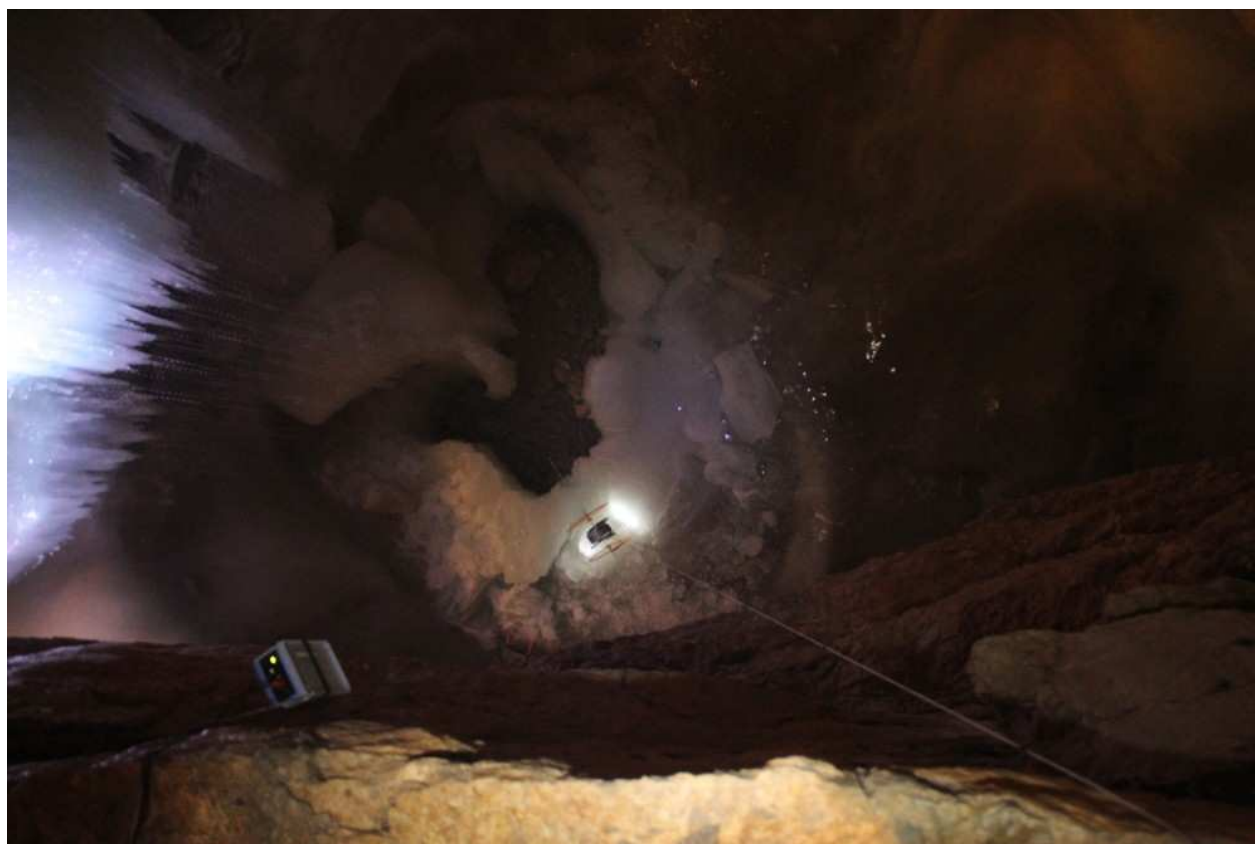
10.16.11: the CRV 15 m down in Tristan dome. On the left against the rock, the reception box. This picture correspond to the time 4.00 on the on board camera.

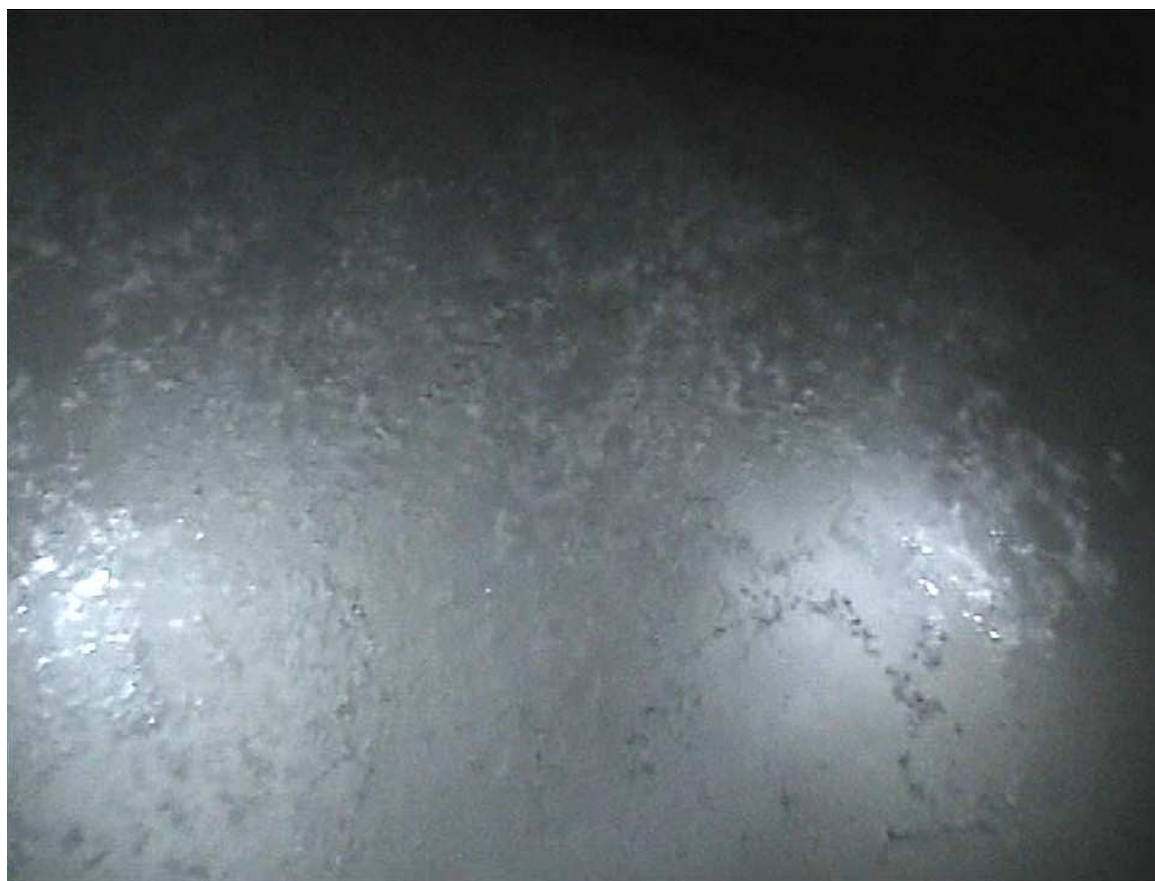
R 6.46: close up on ice (field of view of around 30 cm)

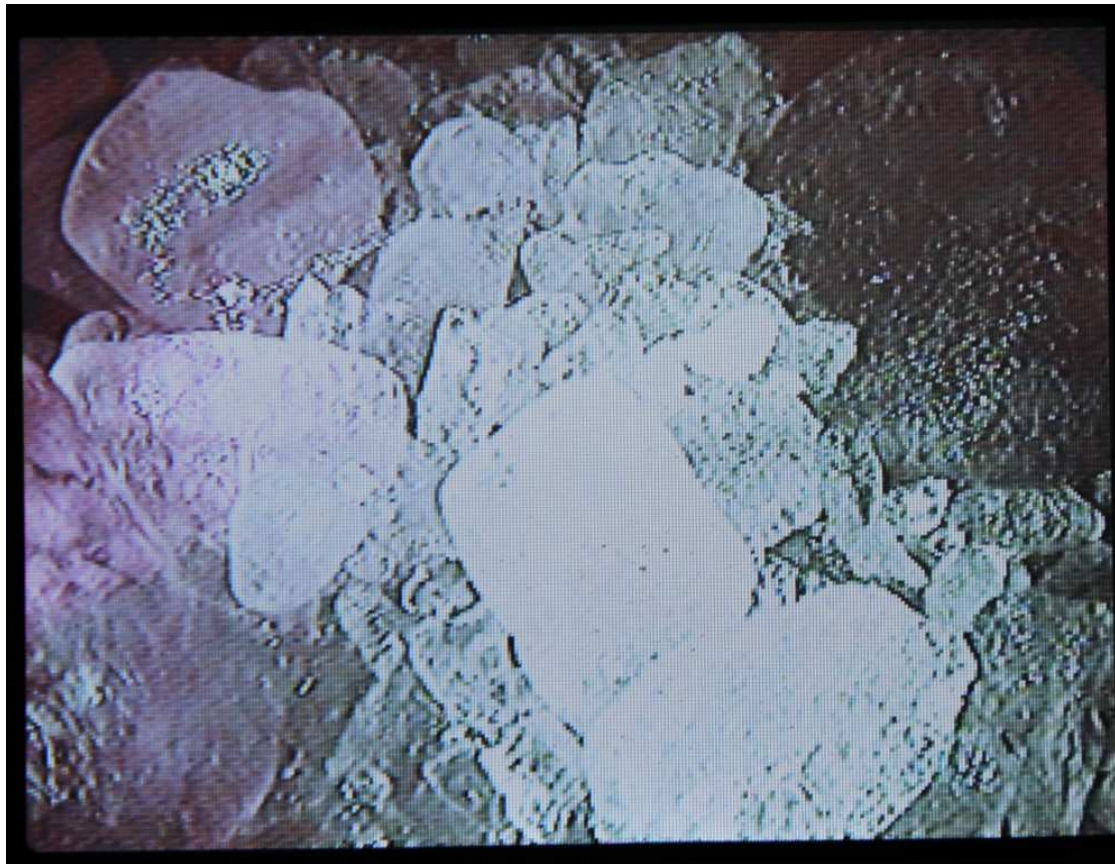
10.20.24: hazcam view.

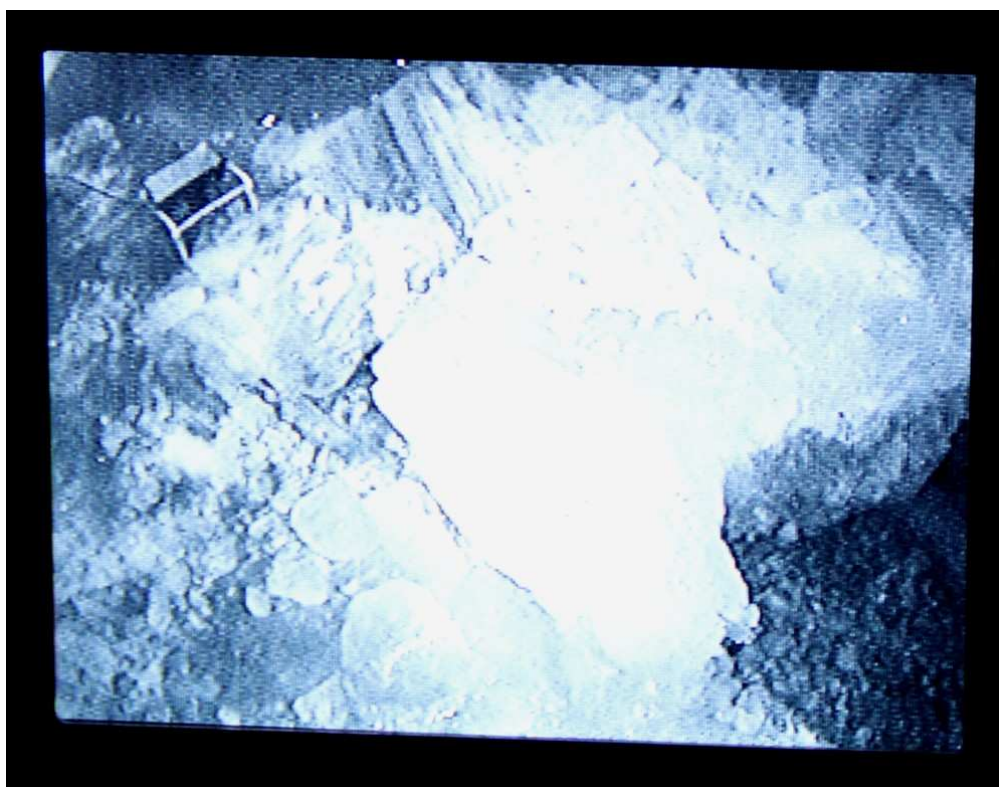
10.28.31: hazcam view showing the hole on the right and the light on the upper left (same one as seen on photos above).

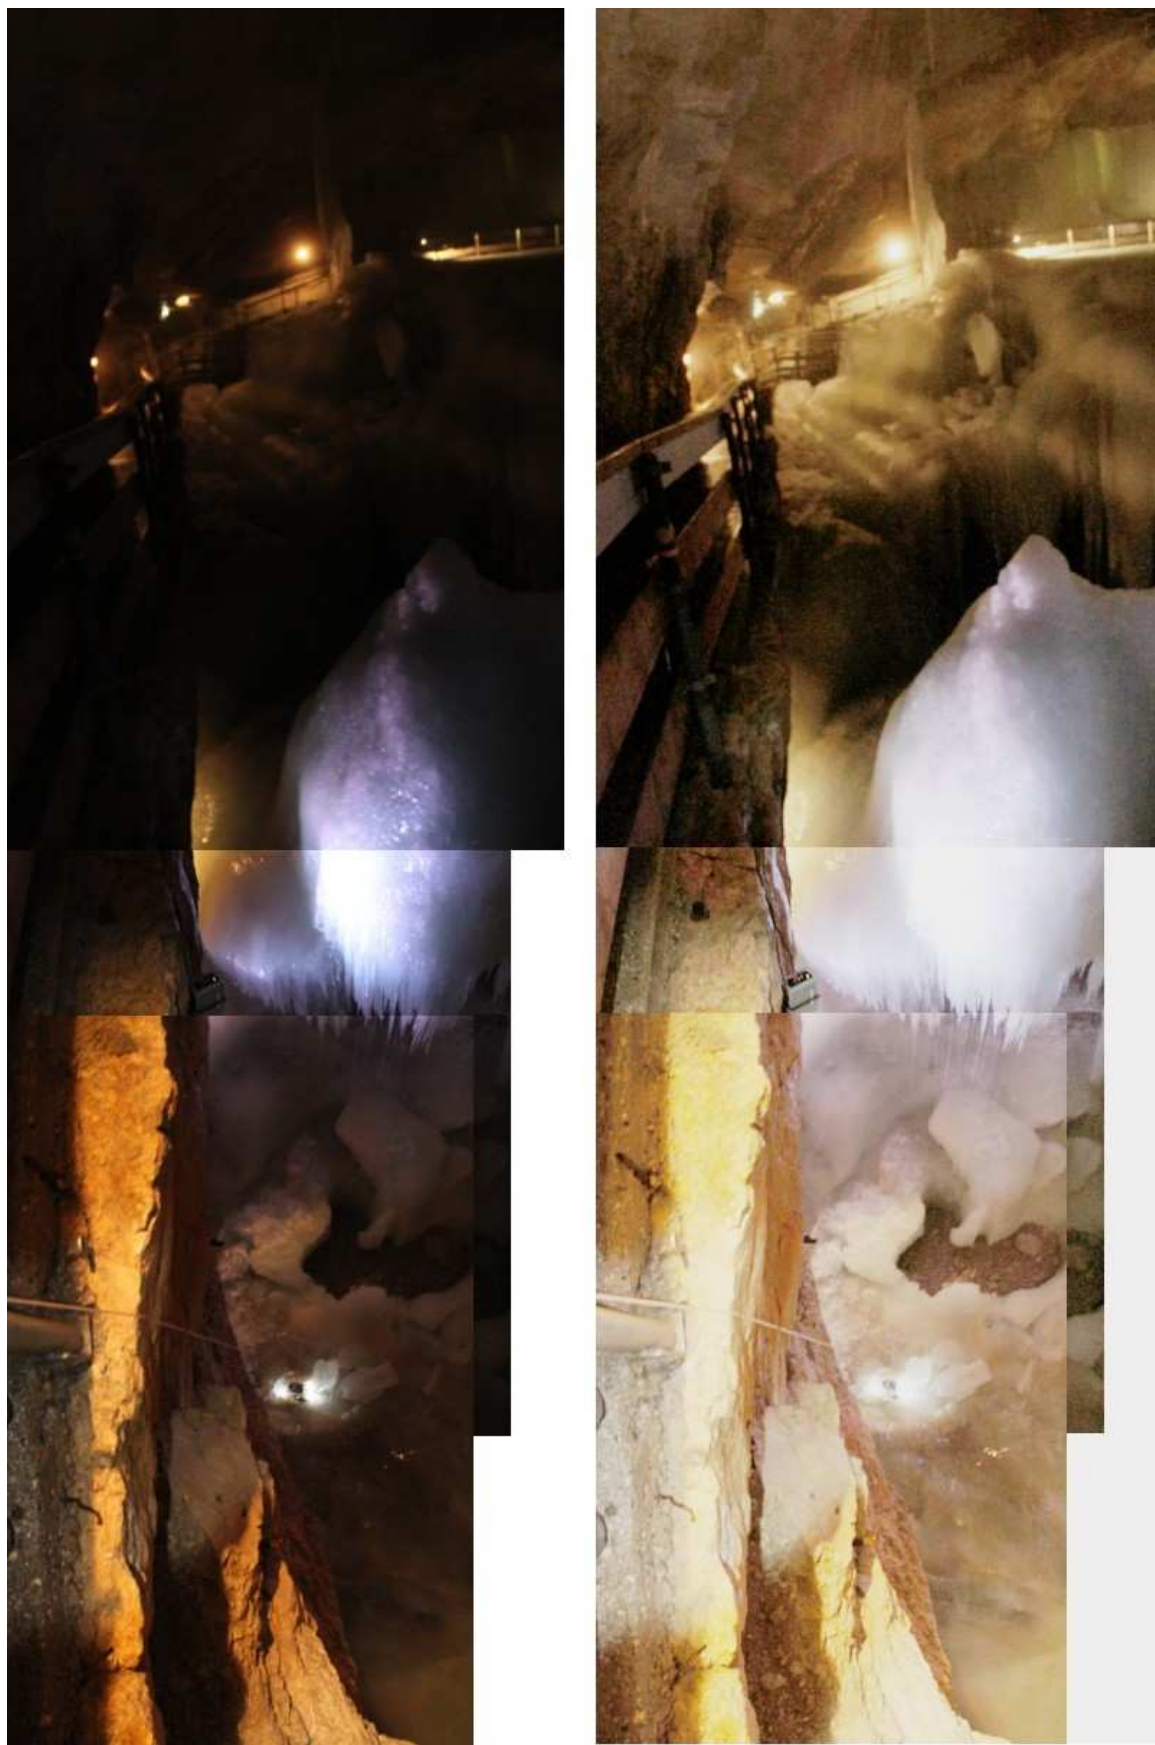
**10.33.41: panorama from vertical down to horizontal. The CRV is slightly farther from the hole.
The same view brightened is shown on the right.**

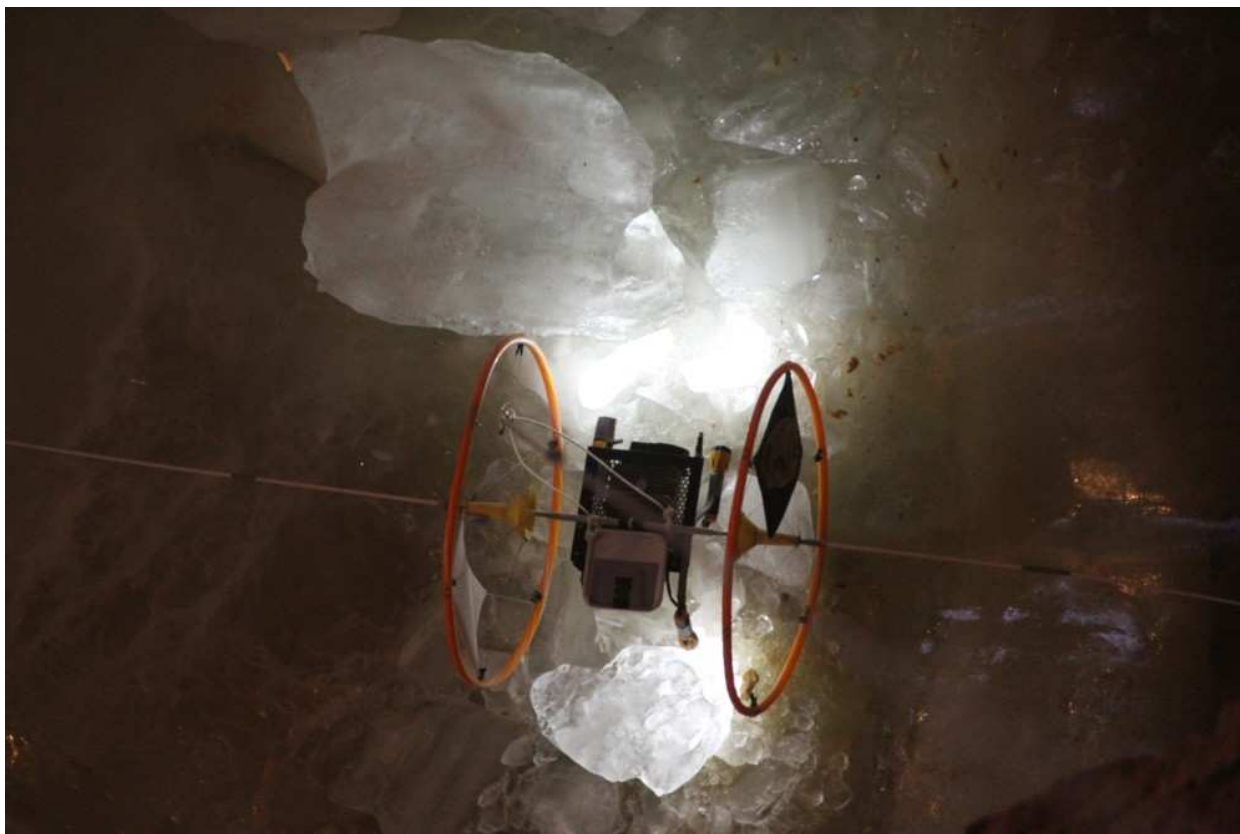
10.33.45: vehicle still down. 10.33.45 corresponds to 21.35 for the on board pictures.

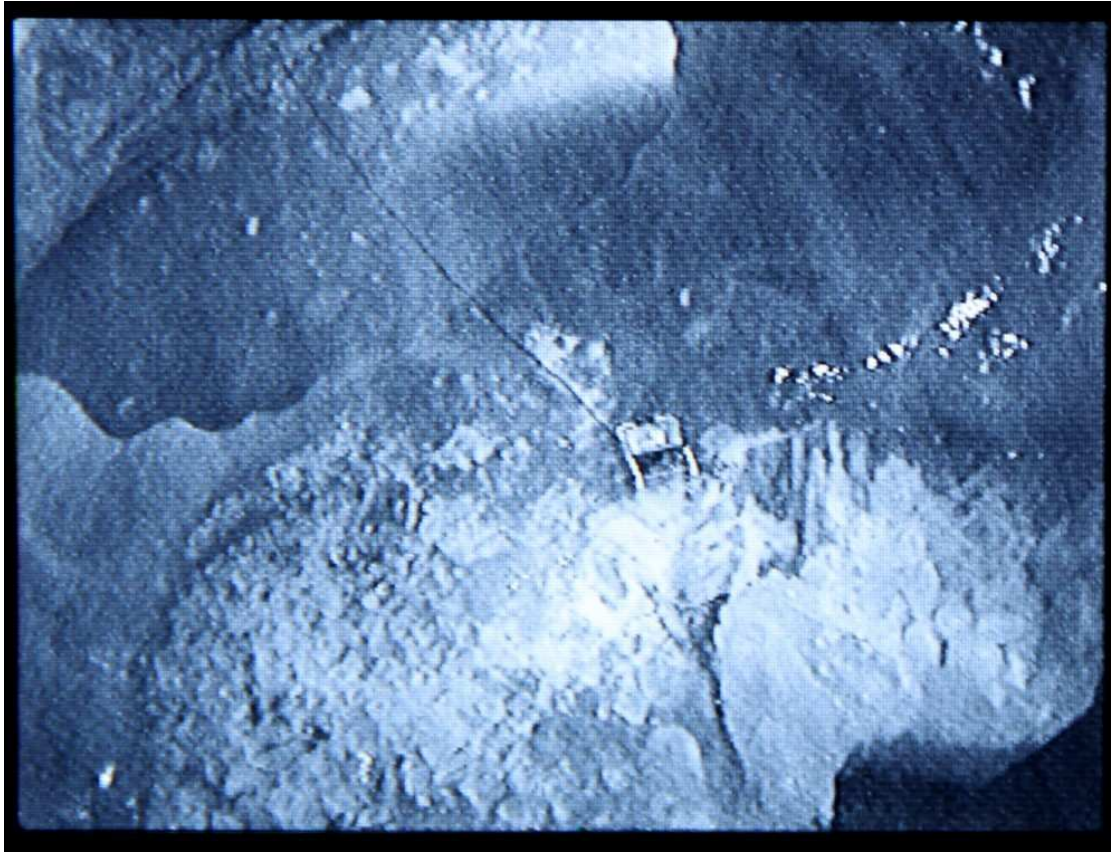
10.37.24: hazcam view showing the hole (bottom right), and a light. The vehicle has now been raised 5 m above the ground. 10.37.24 corresponds to 25.14 for the on board pictures.

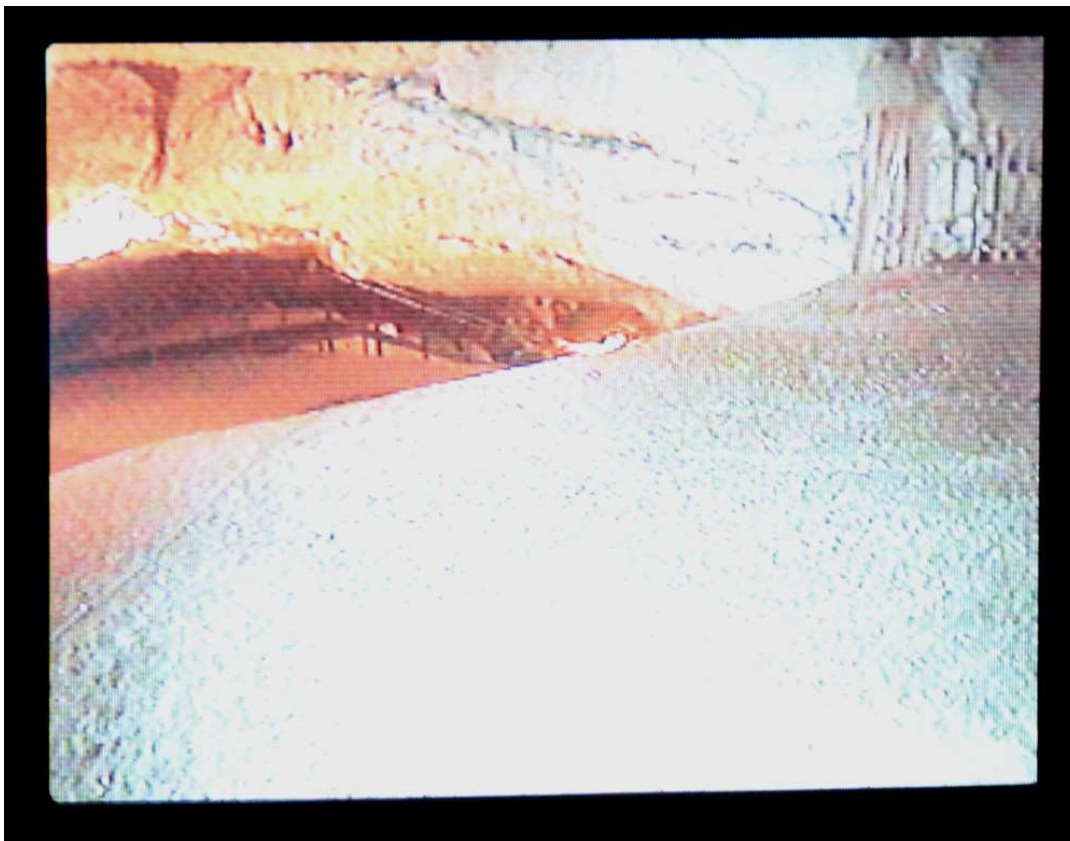
12.35.28: view transmitted by the hazcam at the beginning of CRV 88 test showing the ice slope and, on the left, the pathway which allows observation on the whole length of the slope.

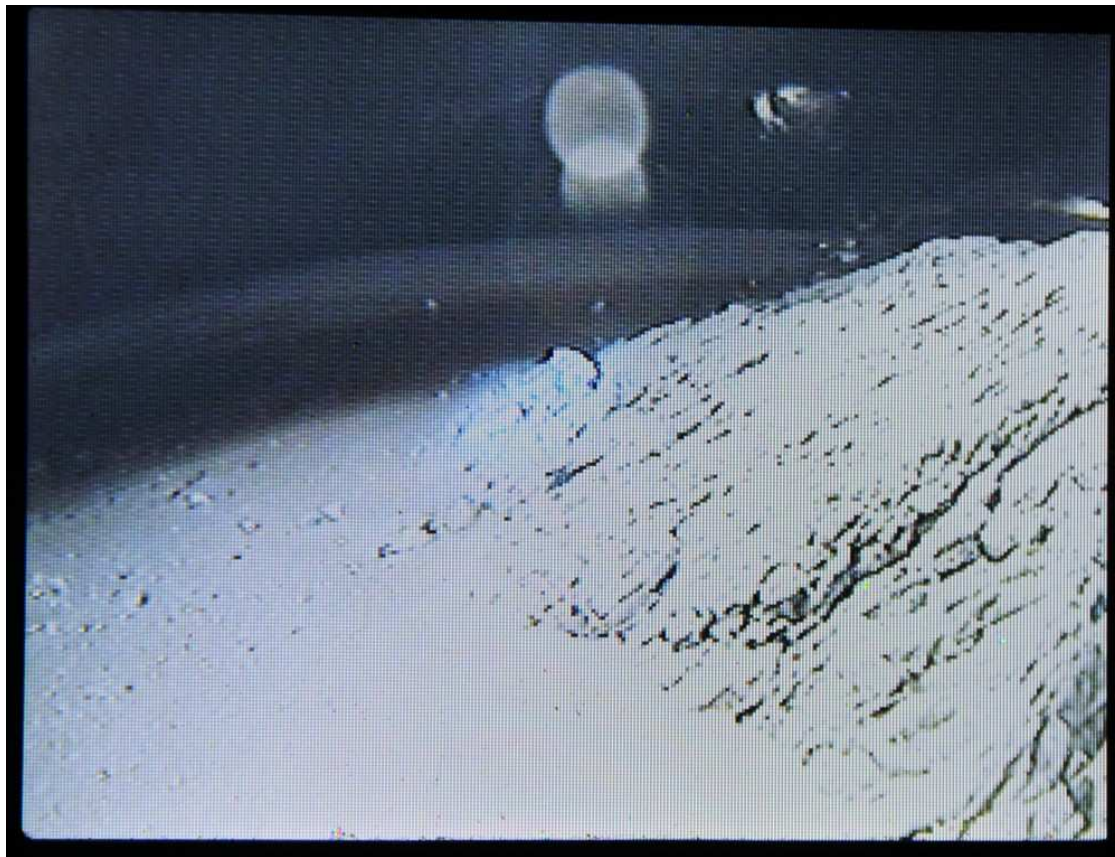
12.39.36: one of the last pictures transmitted. The vehicle is no more in line of sight after going down a 2 m ice bank. The rope is at 15 m. A rock stands in the middle of the way but does not seem a large obstacle. The picture is acquired even with a rather high thickness of ice between the emitter and the receiver as seen in the photo under but the signal will be lost shortly after without any more move of the vehicle. Receiving box battery is still at 12.73 V so is the signal lost by ice absorption or because the battery level is low on board after the preceding test?

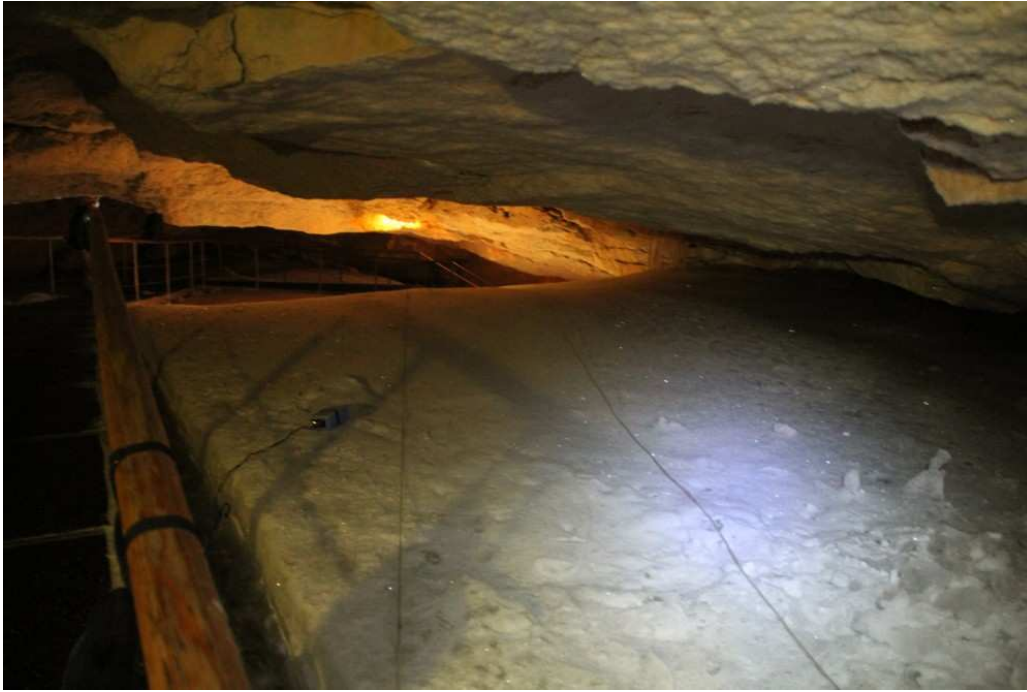
The vehicle is no more visible behind the bank. The receiver is on the ice on the left. I try to bring back the vehicle by some meters to acquire again the video signal but it appears to be blocked. One anti roll rod appears canted 45° behind the icy slope (not visible on the photo) indicating that the CRV is in a difficult situation. The attempt to pilot a ride only by monitoring the hazcam video transmission has to be stopped there and the situation has to be assessed now visually from the pathway.

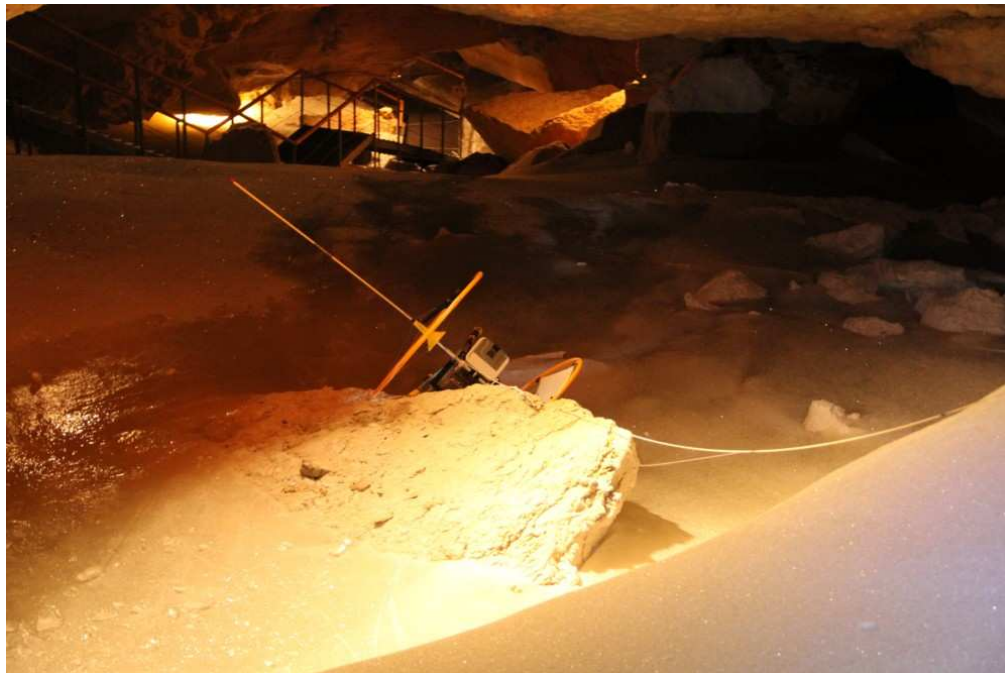
12.48.53: understanding the blockage; the vehicle probably crossed the rock on the left side, then came back on the rock on the right side when I pulled the rope. The right anti roll rod is doing its job, avoiding a tip over of the vehicle.

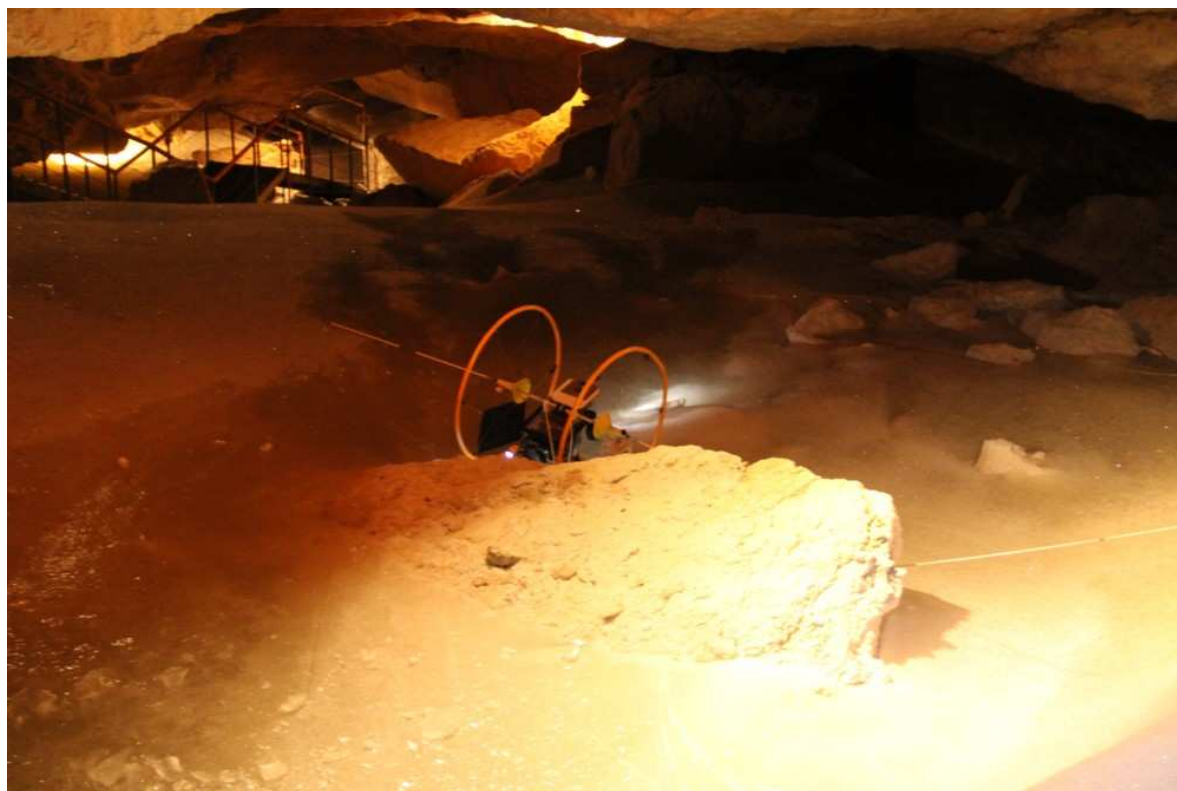
12.51.59: after some pull and release maneuvers of the rope, the vehicle is freed but on a flat surface and at 90° orientation to the general slope.

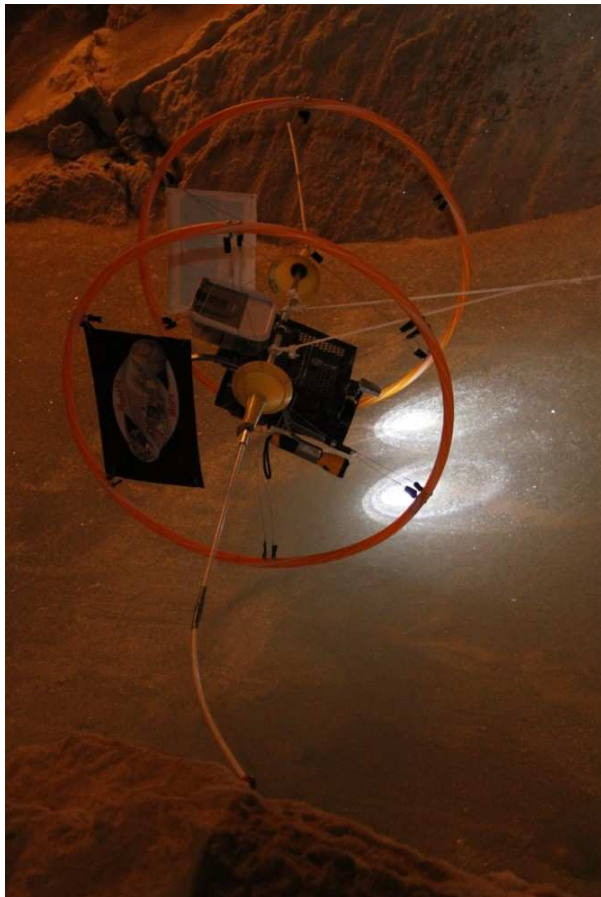
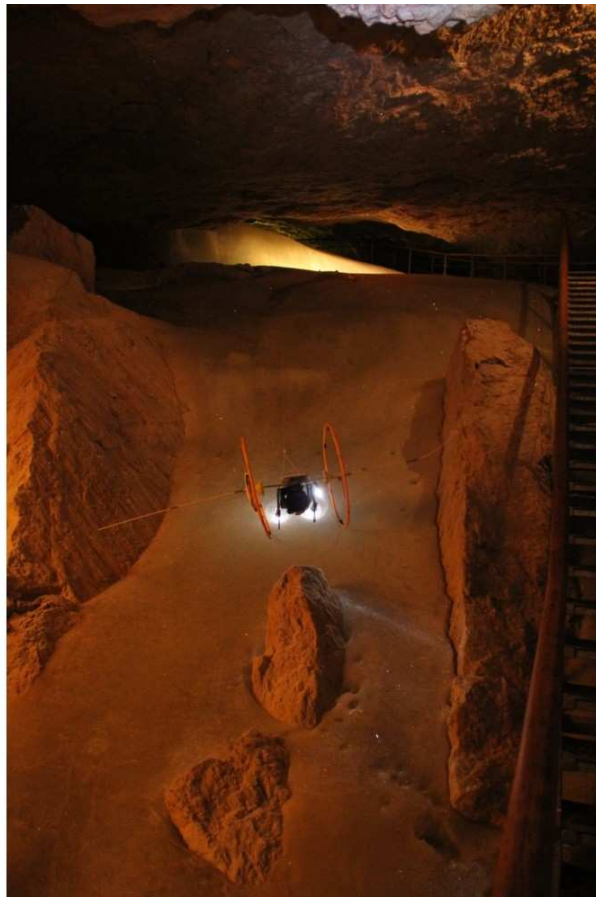
13.07.31 and 13.08.01: rope at 30 m. In the left photo the anti roll rod characteristics are clearly visible: the first half is rigid and the second half flexible. On the other side the anti roll rod fixation has been deformed when the vehicle was stuck behind the rock. On the right photo nearly all the slope is visible. The starting point is on the pathway above the brightly lighted ice bank.

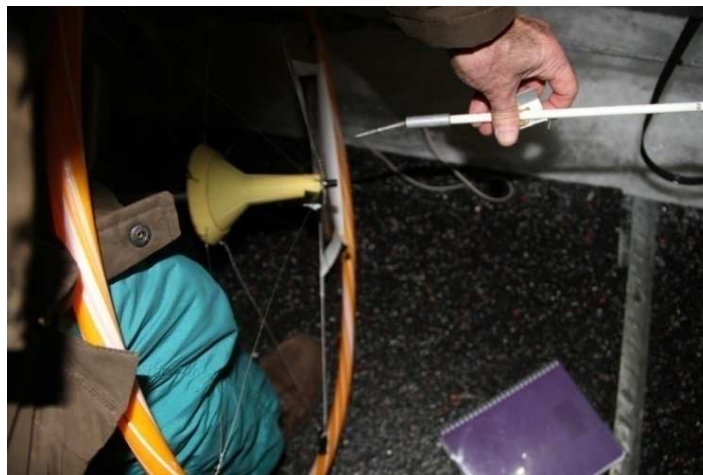
13.25.19: right anti roll rod bent during the blockage behind the rock.

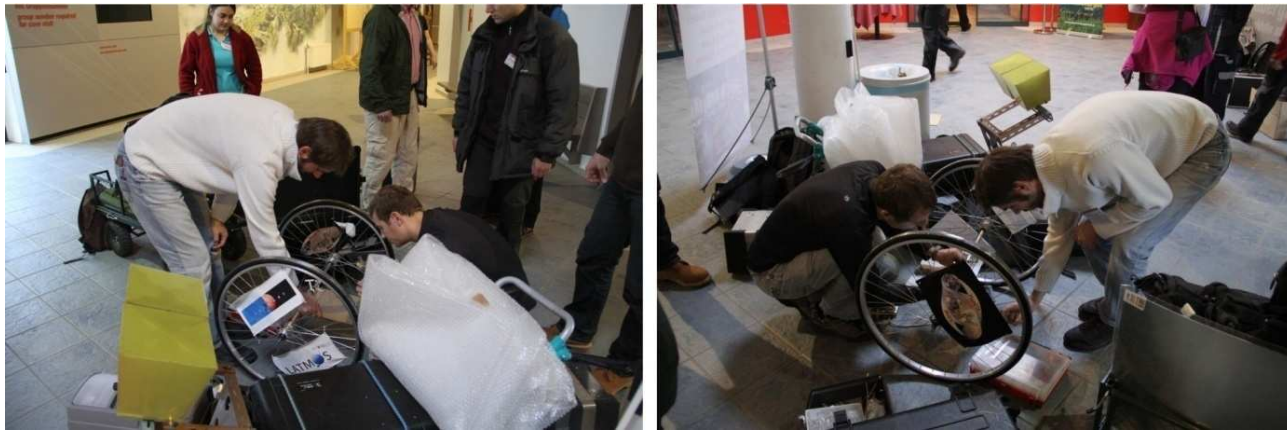
The CRV 5 in the cable car station. The Exomars ground radar antennas are the light yellow truncated pyramids.

The CRV 5 was built to allow the Latmos laboratory to test the Exomars ground sounding radar on slopes. To support a higher weight compared to the CRV 3-3, the vehicle is based on bicycle wheels. Initially these wheels were not equipped with tires but the Latmos team added tires in order to increase the height between the instrument plate and the ground. The Latmos team modified the instrument support plate and, as the weight of the vehicle was around twice the weight of the CRV 3, an electric winch was purchased. Antiroll rods were provided to Latmos but were not used, the slopes on which the vehicle was operating being smooth and shallow.

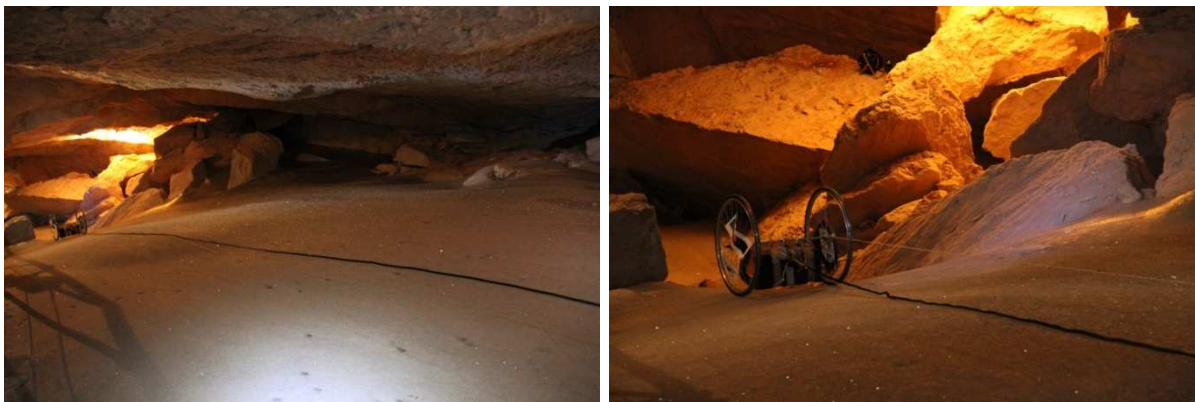
CRV 5 utilization by the Latmos team on the ice slope between Tristram and Percival dome the 29th of April.

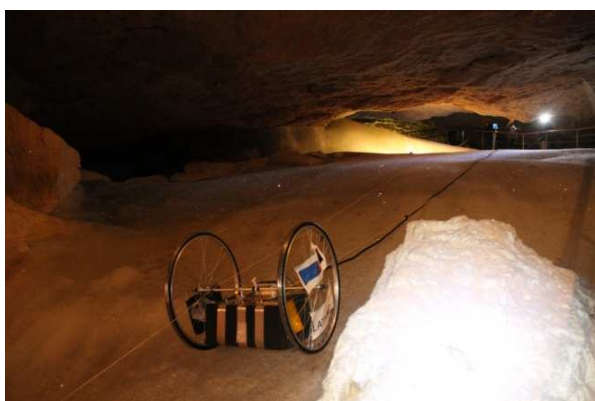
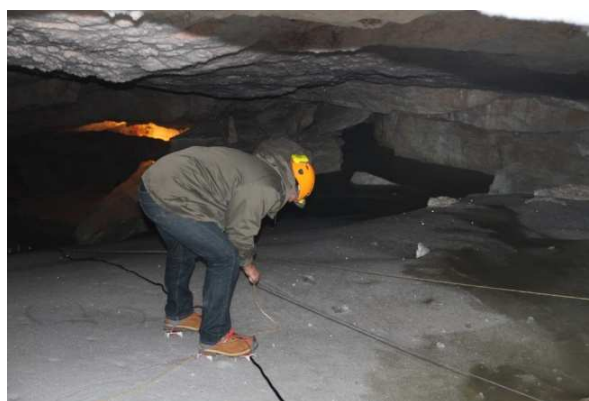
CRV 5 utilization by the Latmos team the 29 th of April.

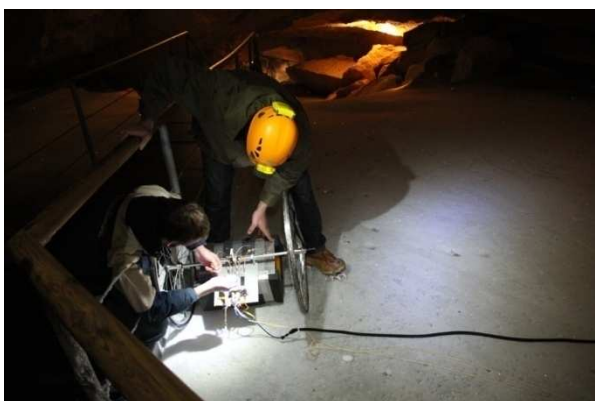
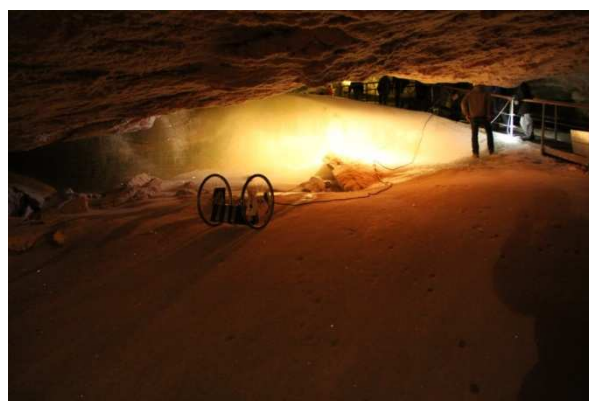
CRV 5 utilization by the Latmos team on the same slope the 30 th of April.

For these runs the CRV 5 started from below the rock which was the cause of difficulties in the CRV 3-3 88 test.

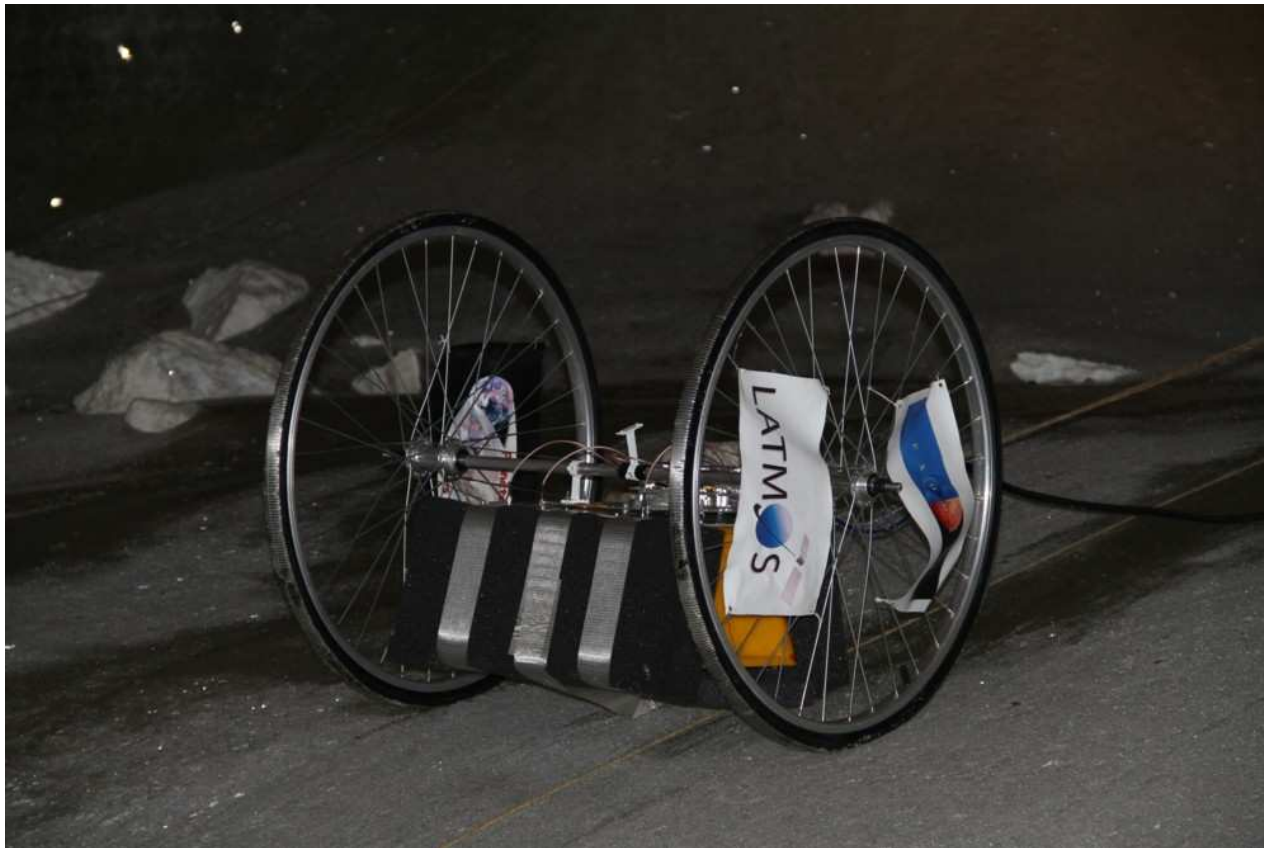
The CRV 5 from front side with the foam protected antennas (and on the wheel on the left the Association Planète Mars logo)

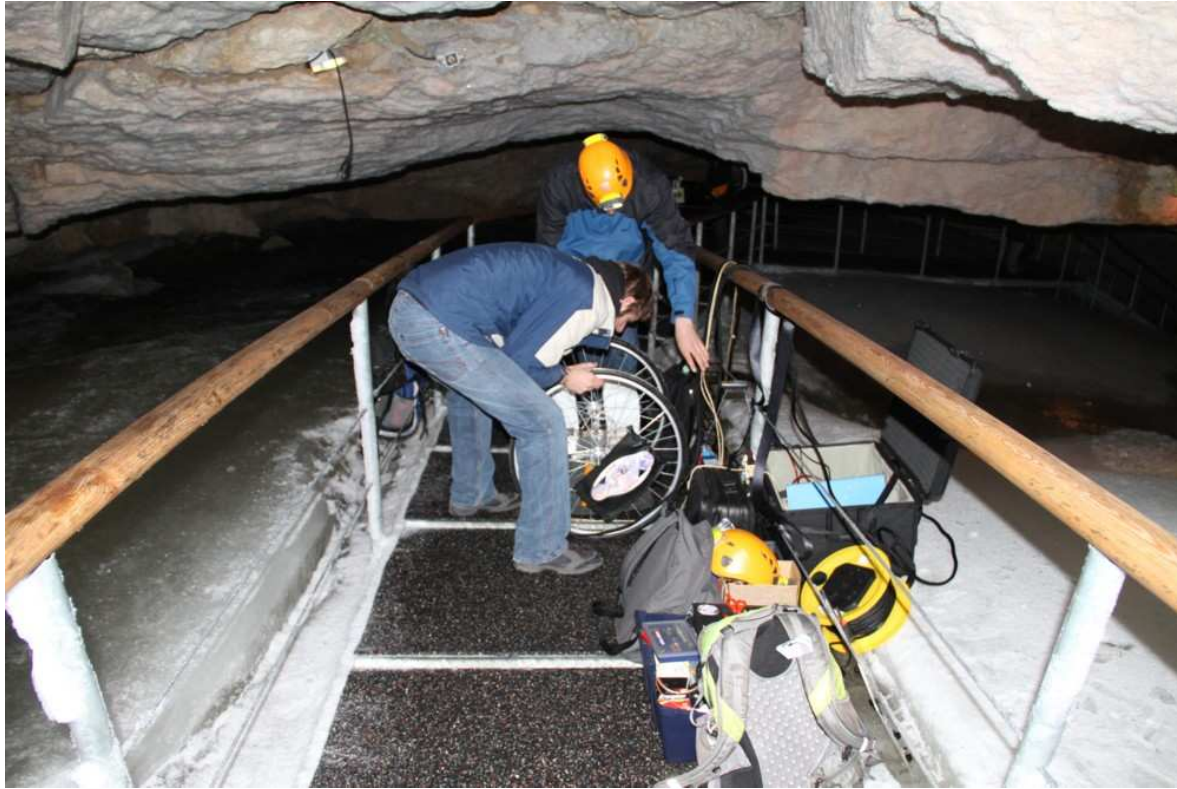
Operation of the radar on CRV 5 is naturally more complex than the simple camera on CRV 3-3.

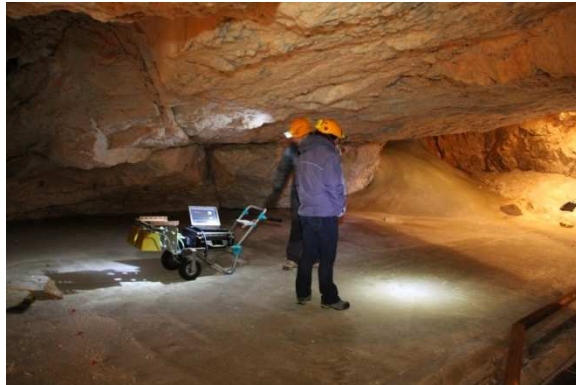
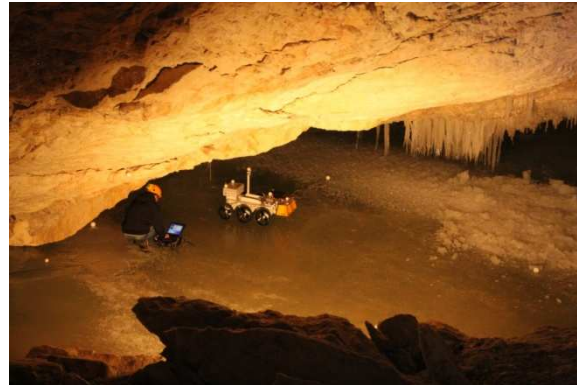
On flat surfaces the Latmos team used a traditional cart (left in the reduction tunnel between Tristan dome and Percival dome) or the polish rover (right in the upper part of Percival dome).
